Access Compliance Report

Public Rights-of-Way

(Curb Ramps)

Intersection ID: 16436	Main Street: HAMPTON_AV	Cross Street: PORTLAND_AV	Location: NE
ADA ID: 6DA0BBBDAA5A	Ramp Type: PerpDiag	Initial Pass/Fail: Fail	Overall Compliance: No
		Severity Score: 10

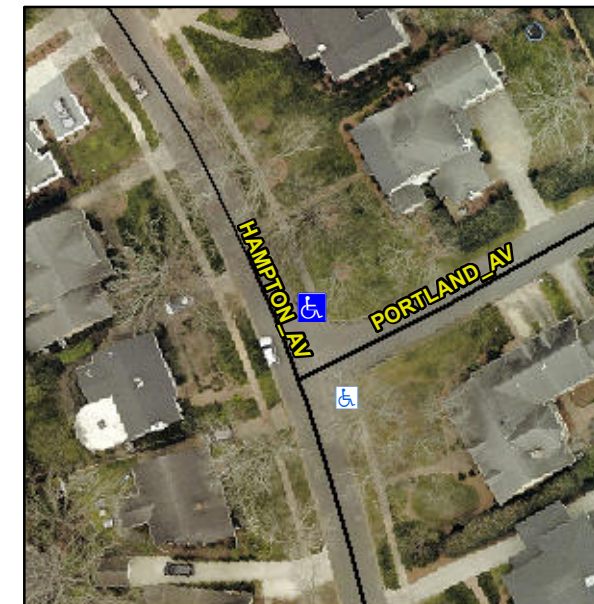
Not Found, R304.5.1, R304.5.3

Compliance	Description	Data	Compliance	Description	Data
N/A	Ramp Length (in)	84.0	Yes	Ramp Slope (%)	6.5
No	Ramp Width (in)	45.0	No	Ramp XSlope (%)	2.7
N/A	Flare Type LT	N/A	N/A	Flare Type RT	N/A
N/A	Flare Slope LT (%)	N/A	N/A	Flare Slope RT (%)	N/A
N/A	Flare Traversable LT?	N/A	N/A	Flare Traversable RT?	N/A
N/A	Landing Length (in)	N/A	N/A	DWS Provided?	N/A
N/A	Landing Width (in)	N/A	N/A	DWS Contrast?	N/A
N/A	Landing Slope (%)	N/A	N/A	DWS Length (in)	N/A
N/A	Landing X Slope (%)	N/A	N/A	DWS Full Width?	N/A
N/A	Landing Curb? (Y/N)	N/A	N/A	DWS Offset (in)	N/A
N/A	Shared Landing?	N/A			
N/A	Gutter Ponding?	N/A	N/A	Gutter Slope (%)	N/A
N/A	Gutter Lip Ht (in)	N/A	N/A	Gutter X Slope (%)	N/A
N/A	Painted X Walk1?	No	N/A	Painted X Walk2?	No
	X Walk 1 Direction	To W		X Walk 2 Direction	To S
N/A	X Walk 1 Width (in)	N/A	N/A	X Walk 2 Width (in)	N/A
	X Walk 1 Slope (%)	3.7		X Walk 2 Slope (%)	0.5
	X Walk 1 X Slope (%)	0.1		X Walk 2 X Slope (%)	0.1

N/A	Ramp inside XWalk1?	N/A	N/A	Ramp inside XWalk2?	N/A
	Road Slope (%)	1.0	N/A	Clear Space?	N/A
	Road X Slope (%)	1.0	N/A	Clear Space to XWalk (in)	N/A
N/A	Any Obstructions?	N/A	N/A	Storm Grate/Utility Hazard?	N/A
	Obstruction Type			Storm Grate/Utility Type	
		N/A			N/A
		Yes		Surface Condition? (G/P)	Good

Remove & Replace Curb Ramp With Two New Directional Ramps or Equivalent.

Total Cost: \$ 3200.00
