# Access Compliance Report

## Public Rights-of-Way

### (Curb Ramps)

Intersection ID: 19259	Main Street: PEBBLESTONE_DR	Cross Street: VILLAGE_LAKE_DR	Location: NW
ADA ID: 6DB03D09EE27	Ramp Type: PerpDiag	Initial Pass/Fail: Fail	Overall Compliance: No
			Severity Score: 13.75

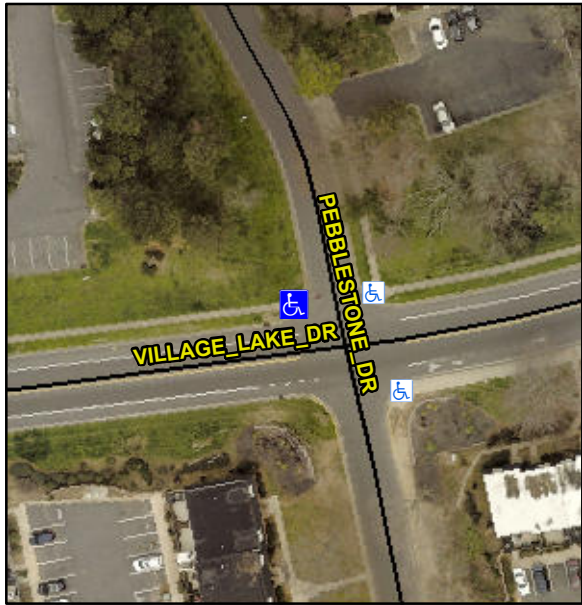
Possible Solutions:	<b>Compliance</b>	<b>Description</b>	<b>Data</b>	<b>Compliance</b>	<b>Description</b>	<b>Data</b>	
	<b>Remove &amp; Replace Curb Ramp With Two New Directional Ramps or Equivalent.</b>	N/A	Ramp Length (in)	39.0	No	Ramp Slope (%)	9.5	
		Yes	Ramp Width (in)	48.0	No	Ramp XSlope (%)	2.1	
		N/A	Flare Type LT	N/A	N/A	Flare Type RT	N/A	
		N/A	Flare Slope LT (%)	N/A	N/A	Flare Slope RT (%)	N/A	
		N/A	Flare Traversable LT?	N/A	N/A	Flare Traversable RT?	N/A	
		N/A	Landing Length (in)	N/A	N/A	DWS Provided?	N/A	
		N/A	Landing Width (in)	N/A	N/A	DWS Contrast?	N/A	
		N/A	Landing Slope (%)	N/A	N/A	DWS Length (in)	N/A	
		N/A	Landing X Slope (%)	N/A	N/A	DWS Full Width?	N/A	
Surveyor Notes:	N/A	N/A	Landing Curb? (Y/N)	N/A	N/A	DWS Offset (in)	N/A	
		N/A	Shared Landing?	N/A				
		N/A	Gutter Ponding?	N/A	N/A	Gutter Slope (%)	N/A

N/A	Gutter Lip Ht (in)	N/A	N/A	Gutter X Slope (%)	N/A	
		N/A	Painted X Walk1?	No	N/A	Painted X Walk2?	No	
			X Walk 1 Direction	To S		X Walk 2 Direction	To E	
		N/A	X Walk 1 Width (in)	N/A	N/A	X Walk 2 Width (in)	N/A	
			X Walk 1 Slope (%)	2.6		X Walk 2 Slope (%)	2.8	
			X Walk 1 X Slope (%)	2.6		X Walk 2 X Slope (%)	2.6	
	PROW/ADA:	Not Found, R304.2.2, R304.5.3	N/A	Ramp inside XWalk1?	N/A	N/A	Ramp inside XWalk2?	N/A
			Road Slope (%)	2.5	N/A	Clear Space?	N/A	
			Road X Slope (%)	3.0	N/A	Clear Space to XWalk (in)	N/A	
N/A			Any Obstructions?	N/A	N/A	Storm Grate/Utility Hazard?	N/A	
			Obstruction Type			Storm Grate/Utility Type		
					N/A		N/A	
					Yes	Surface Condition? (G/P)	Good	
Total Cost:			\$	3200.00
