## Access Compliance Report Public Rights-of-Way (Curb Ramps)

Intersection ID: 17113 Main Street: STERLING\_RD Cross Street: WESTFIELD\_RD Location: SE

ADA ID: 6DB7EF8676AE Ramp Type: Perp Initial Pass/Fail: Fail Overall Compliance: No Severity Score: 13.75

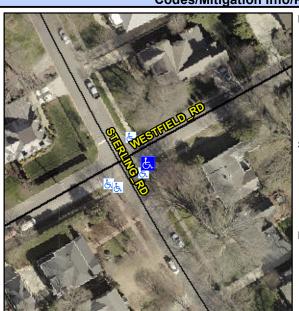
A STATE OF THE PARTY OF THE PAR	PERSONAL PROPERTY AND ADDRESS OF THE PERSONAL PR
Street 1 Name	WESTFIELD RD
Stop Condition-Street 2	StopSign
Street 2 Name	N/A
Stop Condition-Street 1	N/A

Field Measurements/Component Compliance								
Comp	liance Description	Data	Comp	liance Description	Data			
N/A	Ramp Length (in)	57.0	No	Ramp Slope (%)	9.2			
Yes	Ramp Width (in)	51.0	No	Ramp XSlope (%)	2.5			
N/A	Flare Type LT	N/A	N/A	Flare Type RT	N/A			
N/A	Flare Slope LT (%)	N/A	N/A	Flare Slope RT (%)	N/A			
N/A	Flare Traversable LT?	N/A	N/A	Flare Traversable RT?	N/A			
N/A	Landing Length (in)	N/A	N/A	DWS Provided?	N/A			
N/A	Landing Width (in)	N/A	N/A	DWS Contrast?	N/A			
N/A	Landing Slope (%)	N/A	N/A	DWS Length (in)	N/A			
N/A	Landing X Slope (%)	N/A	N/A	DWS Full Width?	N/A			
N/A	Landing Curb? (Y/N)	N/A	N/A	DWS Offset (in)	N/A			
N/A	Shared Landing?	N/A						
N/A	Gutter Ponding?	N/A	N/A	Gutter Slope (%)	N/A			
N/A	Gutter Lip Ht (in)	N/A	N/A	Gutter X Slope (%)	N/A			
N/A	Painted X Walk1?	No	N/A	Painted X Walk2?	N/A			
	X Walk 1 Direction	To NW		X Walk 2 Direction	N/A			
N/A	X Walk 1 Width (in)	N/A	N/A	X Walk 2 Width (in)	N/A

X Walk 1 Slope (%)	4.0		X Walk 2 Slope (%)	N/A			
	X Walk 1 X Slope (%)	0.4		X Walk 2 X Slope (%)	N/A			
N/A	Ramp inside XWalk1?	N/A	N/A	Ramp inside XWalk2?	N/A			
	Road Slope (%)	N/A	N/A	Clear Space?	N/A			
	Road X Slope (%)	N/A	N/A	Clear Space to XWalk	(in) <b>N/A</b>			
N/A	Any Obstructions?	N/A	N/A	Storm Grate/Utility Ha	zard? N/A			
	Obstruction Type			Storm Grate/Utility Typ	pe			
		N/A			N/A			
			Yes	Surface Condition? (G	i/P) Good

Possible Solutions:	
Remove & Replace Entire Ramp.	-
·	,
	ı
	-
Surveyor Notes:	1
N/A	1
	ı
	1
PROW/ADA:	ı
Not Found, R304.2.2, R304.5.3	ı
,,,	
•	
	1
