Access Compliance Report

Public Rights-of-Way

(Curb Ramps)

Intersection ID: 11309	Main Street: MASON_CR	Cross Street: THE_PLAZA	Location: E
ADA ID: 6DBB54C81828	Ramp Type: Perp	Initial Pass/Fail: Fail	Overall Compliance: No
		Severity Score: 25

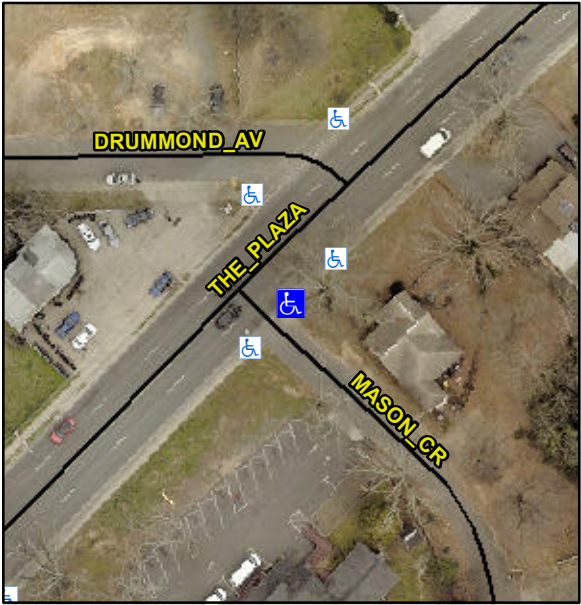
Possible Solutions:		Compliance	Description	Data
	Remove & Replace Entire Ramp.		No	Ramp Length (in)	36.5
			Yes	Ramp Width (in)	64.0
			N/A	Flare Type LT	N/A
			N/A	Flare Slope LT (%)	N/A
			N/A	Flare Traversable LT?	N/A
			N/A	Landing Length (in)	N/A
			N/A	Landing Width (in)	N/A
			N/A	Landing Slope (%)	N/A
			N/A	Landing X Slope (%)	N/A
<p>Surveyor Notes:</p> <p>N/A</p> <p>PROW/ADA:</p> <p>Not Found, R304.2.2</p>			N/A	Flare Type RT	N/A
			N/A	Flare Slope RT (%)	N/A
			N/A	Flare Traversable RT?	N/A
			N/A	DWS Provided?	N/A
			N/A	DWS Contrast?	N/A
			N/A	DWS Length (in)	N/A
			N/A	DWS Full Width?	N/A
			N/A	DWS Offset (in)	N/A
			N/A	Gutter Ponding?	N/A
			N/A	Gutter Lip Ht (in)	0.5
			No	Painted X Walk1?	N/A
			To SW	X Walk 2 Direction	N/A
			N/A	X Walk 1 Width (in)	N/A
			N/A	X Walk 1 Slope (%)	1.6

0.4	X Walk 1 X Slope (%)	N/A
			N/A	Ramp inside XWalk1?	N/A
			N/A	Ramp inside XWalk2?	N/A
			N/A	Road Slope (%)	N/A
			N/A	Road X Slope (%)	N/A
			N/A	Any Obstructions?	N/A
			N/A	Obstruction Type	N/A
			N/A	Clear Space?	N/A
			N/A	Clear Space to XWalk (in)	N/A
			N/A	Storm Grate/Utility Hazard?	N/A
			N/A	Storm Grate/Utility Type	N/A
			N/A	Surface Condition? (G/P)	Good
