## Access Compliance Report Public Rights-of-Way (Curb Ramps)

Intersection ID: N/A Main Street: BEREWICK\_TOWN\_CENTRE Cross Street: CADEN\_RD Location: SW

ADA ID: 6DC3D30062EE Ramp Type: Perp Initial Pass/Fail: Fail Overall Compliance: No Severity Score: 1.25

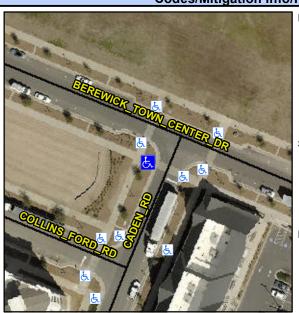
5.7

Ramp Slope (%)

Ramp Width (in)	100.0	No	Ramp XSlope (%)	2.5		
	Flare Type LT	N/A	N/A	Flare Type RT	N/A		
	Flare Slope LT (%)	N/A	N/A	Flare Slope RT (%)	N/A		
	Flare Traversable LT?	N/A	N/A	Flare Traversable RT?	N/A		
	Landing Length (in)	N/A	N/A	DWS Provided?	N/A		
	Landing Width (in)	N/A	N/A	DWS Contrast?	N/A		
	Landing Slope (%)	N/A	N/A	DWS Length (in)	N/A		
	Landing X Slope (%)	N/A	N/A	DWS Full Width?	N/A		
	Landing Curb? (Y/N)	N/A	N/A	DWS Offset (in)	N/A		
	Shared Landing?	N/A					
	Gutter Ponding?	N/A	N/A	Gutter Slope (%)	N/A		
	Gutter Lip Ht (in)	N/A	N/A	Gutter X Slope (%)	N/A		
	Painted X Walk1?	Yes	N/A	Painted X Walk2?	N/A		
	X Walk 1 Direction	To SE		X Walk 2 Direction	N/A		
	X Walk 1 Width (in)	97.0	N/A	X Walk 2 Width (in)	N/A		
	X Walk 1 Slope (%)	0.9		X Walk 2 Slope (%)	N/A		
	X Walk 1 X Slope (%)	1.7		X Walk 2 X Slope (%)	N/A		
	Ramp inside XWalk1?	Yes	N/A	Ramp inside XWalk2?	N/A		
	Road Slope (%)	N/A	N/A	Clear Space?	N/A

_	
1	Possible Solutions:
	Remove & Replace Entire Ramp.
300	
No.	
Ser.	Surveyor Notes:
1	N/A
	N/A
1	
X	PROW/ADA:
	R304.5.3
