Access Compliance Report Public Rights-of-Way (Curb Ramps)

Intersection ID: 14070 Main Street: HARRISBURG_RD			Cross	Street:	PENCE_RD	Location:	SW			
ADA ID: 6DD777EC9094 Ramp Type: Perp			Initial	Pass/Fa	ail: Pass Overa	o Severity Score:	15.25			
Codes/Mitigation Info/Possible Solution					Field Measurements/Component Compliance					
Possible Solutions:					Compliance Description Data Compliance					Data
A A A A A A A A A A A A A A A A A A A				Domn		Ramp Length (in)	60.0		Ramp Slope (%)	5.8
	IE	Remove & Replace Enti Remove & Replace Gut		p.	N/A Yes	Ramp Width (in)		Yes	,	5.8 4.5
	18 1	Keniove & Kepiace Gut	ler.		N/A	,			Ramp XSlope (%)	4.5 N/A
PENGE	MEL AND					Flare Type LT	Sloped		Flare Type RT	
COL PA	1 Bally				N/A	Flare Slope LT (%)		No	Flare Slope RT (%)	11.2
The State of	A Alla				N/A	Flare Traversable LT?	Yes		Flare Traversable RT?	Yes
					No	Landing Length (in)		Yes	DWS Provided?	Yes
		Surveyor Notes:			No	Landing Width (in)	N/A		DWS Contrast?	Yes

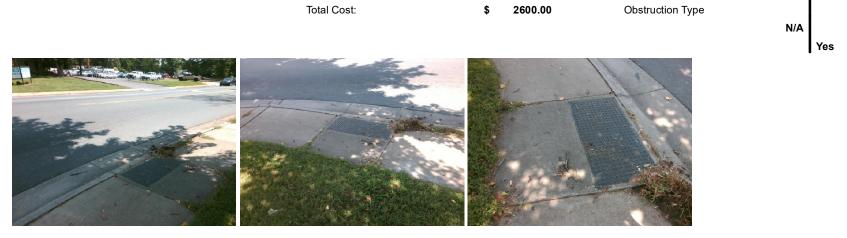
N/A			No	Landing Slope (%)	N/A	Yes	DWS Length (in)	24.0
					No	Landing X Slope (%)	N/A	No	DWS Full Width?	No
					N/A	Landing Curb? (Y/N)	No	Yes	DWS Offset (in)	2.0
					N/A	Shared Landing?	No			
the states		PROW/ADA:			Yes	Gutter Ponding?	No	Yes	Gutter Slope (%)	3.6
		Not Found, R304.2.1, R30	304.2.2-	04.2.2-Perp,	Yes	Gutter Lip Ht (in)	0.0	No	Gutter X Slope (%)	5.0
A CALL	1 1 Mar	R304.3.2-Para, R304.5.3			N/A	Painted X Walk1?	No	N/A	Painted X Walk2?	N/A
	11111	R305.1.4				X Walk 1 Direction	To E		X Walk 2 Direction	N/A
	ALL VER				N/A	X Walk 1 Width (in)	N/A	N/A	X Walk 2 Width (in)	N/A
Street 1 Name	HARRISBURG RD	-				X Walk 1 Slope (%)	5.8		X Walk 2 Slope (%)	N/A
Stop Condition-Street 2	None					X Walk 1 X Slope (%)	4.5		X Walk 2 X Slope (%)	N/A
Street 2 Name	N/A				N/A	Ramp inside XWalk1?	N/A	N/A	Ramp inside XWalk2?	N/A
Stop Condition-Street 1	N/A					Road Slope (%)	N/A	N/A	Clear Space?	Yes
						Road X Slope (%)	N/A	N/A	Clear Space to XWalk (in)	N/A

Yes	Any Obstructions?	No		Storm Grate/Utility Hazard?	No
		Total Cost:	\$	2600.00		Obstruction Type			Storm Grate/Utility Type	
			Ψ	2000.00			N/A		Storm Oraco/Otimey Type	N/A
							N/A			IN/ <i>P</i> A

es Surface Condition? (G/P)

Good
