Access Compliance Report Public Rights-of-Way (Curb Ramps)

Intersection ID: 44052 Main Street: KETTLEWELL_LN Cross Street: LONGSTONE_LN Location: S

ADA ID: 6DE25660D3EF Ramp Type: PerpDiag Initial Pass/Fail: Fail Overall Compliance: No Severity Score: 17.5

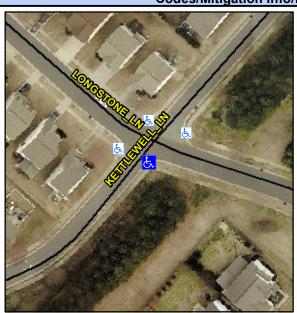
Fleid Measurements/Component Compilance						
	Compliance Description		Data	Compliance Description		Data
ı	N/A	Ramp Length (in)	33.5	Yes	Ramp Slope (%)	6.0
ı	No	Ramp Width (in)	32.0	Yes	Ramp XSlope (%)	1.9
ı	N/A	Flare Type LT	N/A	N/A	Flare Type RT	N/A
ı	N/A	Flare Slope LT (%)	N/A	N/A	Flare Slope RT (%)	N/A
ı	N/A	Flare Traversable LT?	N/A	N/A	Flare Traversable RT?	N/A
ı	N/A	Landing Length (in)	N/A	N/A	DWS Provided?	N/A
ı	N/A	Landing Width (in)	N/A	N/A	DWS Contrast?	N/A
ı	N/A	Landing Slope (%)	N/A	N/A	DWS Length (in)	N/A
ı	N/A	Landing X Slope (%)	N/A	N/A	DWS Full Width?	N/A
ı	N/A	Landing Curb? (Y/N)	N/A	N/A	DWS Offset (in)	N/A
ı	N/A	Shared Landing?	N/A			
ı	N/A	Gutter Ponding?	N/A	N/A	Gutter Slope (%)	N/A
ı	N/A	Gutter Lip Ht (in)	N/A	N/A	Gutter X Slope (%)	N/A
ı	N/A	Painted X Walk1?	No	N/A	Painted X Walk2?	No
		X Walk 1 Direction	To NE		X Walk 2 Direction	To NW
ı	N/A	X Walk 1 Width (in)	N/A	N/A	X Walk 2 Width (in)	N/A

X Walk 1 Slope (%)	2.1		X Walk 2 Slope (%)	1.5
		X Walk 1 X Slope (%)	3.9		X Walk 2 X Slope (%)	1.4
ı	N/A	Ramp inside XWalk1?	N/A	N/A	Ramp inside XWalk2?	N/A
		Road Slope (%)	0.5	N/A	Clear Space?	N/A
		Road X Slope (%)	4.3	N/A	Clear Space to XWalk (in)	N/A
	N/A	Any Obstructions?	N/A	N/A	Storm Grate/Utility Hazard?	N/A
		Obstruction Type			Storm Grate/Utility Type	
			N/A			N/A
				Yes	Surface Condition? (G/P)	Good

Remove & Replace Curb Ramp With Two New Directional Ramps or Equivalent.

R304.5.1
