# Access Compliance Report

## Public Rights-of-Way

### (Curb Ramps)

Intersection ID: 8515	Main Street: ATANDO_AV	Cross Street: STATESVILLE_AV	Location: SE
ADA ID: 6DE71683ECA	Ramp Type: Perp	Initial Pass/Fail: Fail	Overall Compliance: No
			Severity Score: 21.25

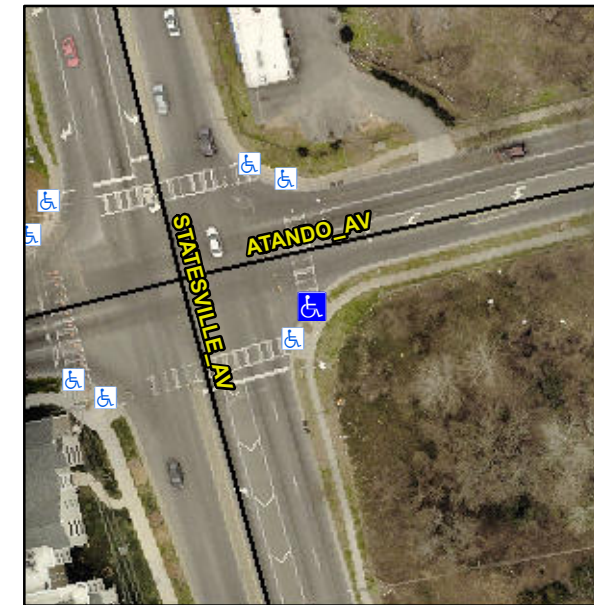
**R304.5.1, R304.2.2**

Compliance	Description	Data	Compliance	Description	Data
N/A	Ramp Length (in)	62.0	No	Ramp Slope (%)	10.3
No	Ramp Width (in)	42.0	Yes	Ramp XSlope (%)	1.3
N/A	Flare Type LT	N/A	N/A	Flare Type RT	N/A
N/A	Flare Slope LT (%)	N/A	N/A	Flare Slope RT (%)	N/A
N/A	Flare Traversable LT?	N/A	N/A	Flare Traversable RT?	N/A
N/A	Landing Length (in)	N/A	N/A	DWS Provided?	N/A
N/A	Landing Width (in)	N/A	N/A	DWS Contrast?	N/A
N/A	Landing Slope (%)	N/A	N/A	DWS Length (in)	N/A
N/A	Landing X Slope (%)	N/A	N/A	DWS Full Width?	N/A
N/A	Landing Curb? (Y/N)	N/A	N/A	DWS Offset (in)	N/A
N/A	Shared Landing?	N/A			
N/A	Gutter Ponding?	N/A	N/A	Gutter Slope (%)	N/A
N/A	Gutter Lip Ht (in)	N/A	N/A	Gutter X Slope (%)	N/A
N/A	Painted X Walk1?	Yes	N/A	Painted X Walk2?	N/A
	X Walk 1 Direction	To N		X Walk 2 Direction	N/A
N/A	X Walk 1 Width (in)	105.0	N/A	X Walk 2 Width (in)	N/A
	X Walk 1 Slope (%)	2.6		X Walk 2 Slope (%)	N/A
	X Walk 1 X Slope (%)	0.3		X Walk 2 X Slope (%)	N/A

N/A	Ramp inside XWalk1?	Yes	N/A	Ramp inside XWalk2?	N/A
	Road Slope (%)	N/A	N/A	Clear Space?	N/A
	Road X Slope (%)	N/A	N/A	Clear Space to XWalk (in)	N/A
N/A	Any Obstructions?	N/A	N/A	Storm Grate/Utility Hazard?	N/A
	Obstruction Type			Storm Grate/Utility Type	
			N/A		N/A
			Yes	Surface Condition? (G/P)	Good

**Remove & Replace Entire Ramp.**
