Access Compliance Report

Public Rights-of-Way

(Curb Ramps)

Intersection ID: 48563	Main Street: MASON_MILL_PL	Cross Street: HAINES_MILL_RD	Location: SW
ADA ID: 6DEAAB6DC0B9	Ramp Type: BlendTrans1	Initial Pass/Fail: Fail	Overall Compliance: No
Severity Score: 33.75			
Codes/Mitigation Info/Possible Solution		Field Measurements/Component Compliance

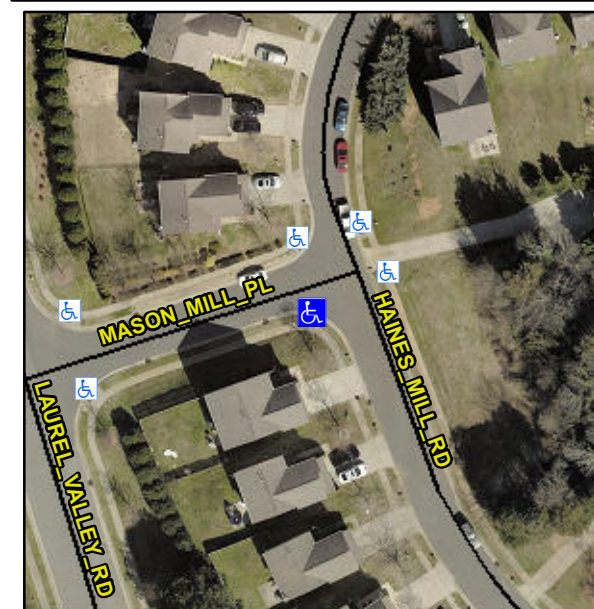
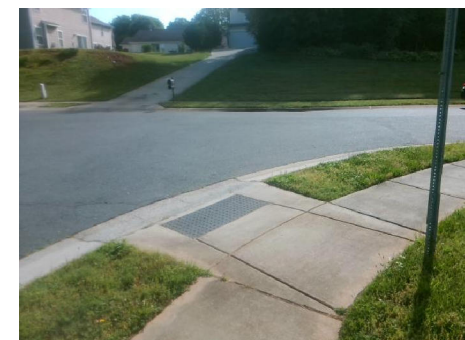
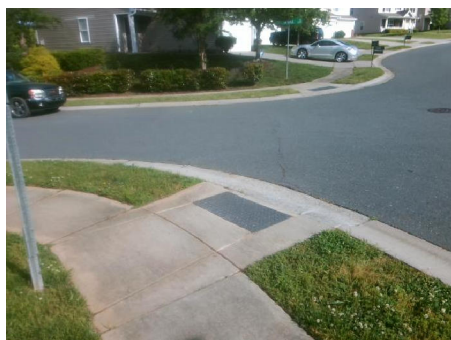
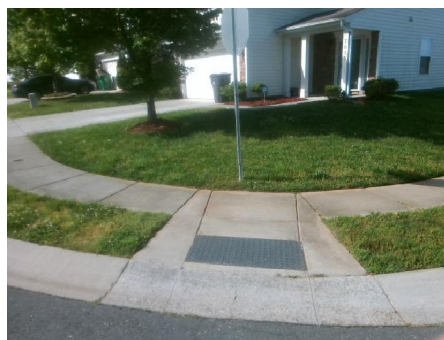
Not Found, R304.5.1, R304.5.3

Compliance	Description	Data	Compliance	Description	Data
N/A	Ramp Length (in)	48.0	Yes	BlendTrans Slope (%)	2.0
No	Ramp Width (in)	47.0	No	BlendTrans XSlope (%)	7.1
N/A	Flare Type LT	N/A	N/A	Flare Type RT	N/A
N/A	Flare Slope LT (%)	N/A	N/A	Flare Slope RT (%)	N/A
N/A	Flare Traversable LT?	N/A	N/A	Flare Traversable RT?	N/A
N/A	Landing Length (in)	N/A	N/A	DWS Provided?	N/A
N/A	Landing Width (in)	N/A	N/A	DWS Contrast?	N/A
N/A	Landing Slope (%)	N/A	N/A	DWS Length (in)	N/A
N/A	Landing X Slope (%)	N/A	N/A	DWS Full Width?	N/A
N/A	Landing Curb? (Y/N)	N/A	N/A	DWS Offset (in)	N/A
N/A	Shared Landing?	N/A			
N/A	Gutter Ponding?	N/A	N/A	Gutter Slope (%)	N/A
N/A	Gutter Lip Ht (in)	N/A	N/A	Gutter X Slope (%)	N/A
N/A	Painted X Walk1?	No	N/A	Painted X Walk2?	No
	X Walk 1 Direction	To E		X Walk 2 Direction	To N
	X Walk 1 Width (in)	N/A		X Walk 2 Width (in)	N/A
	X Walk 1 Slope (%)	6.2		X Walk 2 Slope (%)	2.3
	X Walk 1 X Slope (%)	2.5		X Walk 2 X Slope (%)	5.7

N/A	Ramp inside XWalk1?	N/A	N/A	Ramp inside XWalk2?	N/A
	Road Slope (%)	4.5		Clear Space?	N/A
	Road X Slope (%)	5.2	N/A	Clear Space to XWalk (in)	N/A
N/A	Any Obstructions?	N/A	N/A	Storm Grate/Utility Hazard?	N/A
	Obstruction Type			Storm Grate/Utility Type	
		N/A			N/A
			Yes	Surface Condition? (G/P)	Good
			No	Curb Slope (%)	14.4

Possible Solutions:

Remove & Replace Curb Ramp With Two New Directional Ramps or Equivalent.
