Intersection ID: 10034609	Main Street: PLANTATION_CENTER_DR	Cross Street: N/A	Location:	SW
ADA ID: 6DEEB8A351F6	Ramp Type: Para	Initial Pass/Fail: Fail	Overall Compliance: No	Severity Score: 26.25

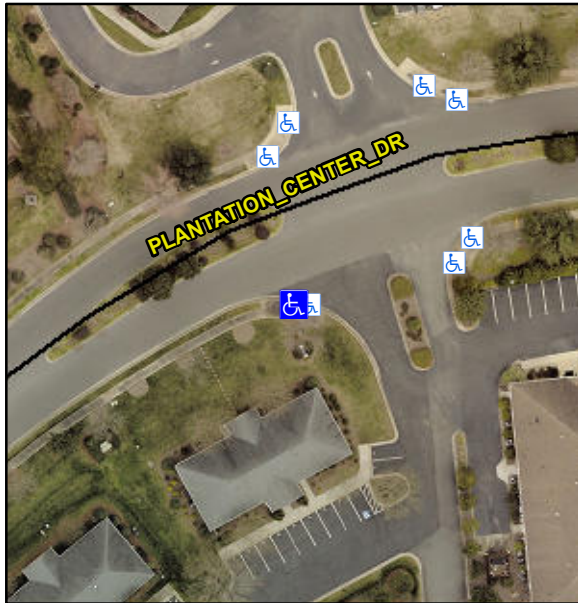
RT RP < 5%

R304.3.2, R304.5.3

Compliance	Description	Data	Compliance	Description	Data
N/A	Ramp Length LT (in)	59.0	N/A	Ramp Length RT (in)	57.0
Yes	Ramp Width LT (in)	108.0	Yes	Ramp Width RT (in)	108.0
No	Ramp Slope LT (%)	12.3	Yes	Ramp Slope RT (%)	3.3
No	Ramp XSlope LT (%)	4.1	No	Ramp XSlope RT (%)	2.3
N/A	Landing Length (in)	N/A	N/A	DWS Provided?	N/A
N/A	Landing Width (in)	N/A	N/A	DWS Contrast?	N/A
N/A	Landing Slope (%)	N/A	N/A	DWS Length (in)	N/A
N/A	Landing X Slope (%)	N/A	N/A	DWS Full Width?	N/A
N/A	Landing Curb? (Y/N)	N/A	N/A	DWS Offset (in)	N/A
N/A	Shared Landing?	N/A			
N/A	Gutter Ponding?	N/A	N/A	Gutter Slope (%)	N/A
N/A	Gutter Lip Ht (in)	N/A	N/A	Gutter X Slope (%)	N/A
N/A	Painted X Walk1?	No	N/A	Painted X Walk2?	N/A
	X Walk 1 Direction	To NW		X Walk 2 Direction	N/A
N/A	X Walk 1 Width (in)	N/A	N/A	X Walk 2 Width (in)	N/A
	X Walk 1 Slope (%)	2.0		X Walk 2 Slope (%)	N/A
	X Walk 1 X Slope (%)	2.8		X Walk 2 X Slope (%)	N/A
N/A	Ramp inside XWalk1?	N/A	N/A	Ramp inside XWalk2?	N/A

Remove & Replace Entire Ramp.
