Access Compliance Report

Public Rights-of-Way

(Curb Ramps)

Intersection ID: 15175	Main Street: SOUTH_BV	Cross Street: POINDEXTER_DR	Location: NE
ADA ID: 6DF5A39CC3D5	Ramp Type: Para	Initial Pass/Fail: Fail	Overall Compliance: No
		Severity Score: 12.5

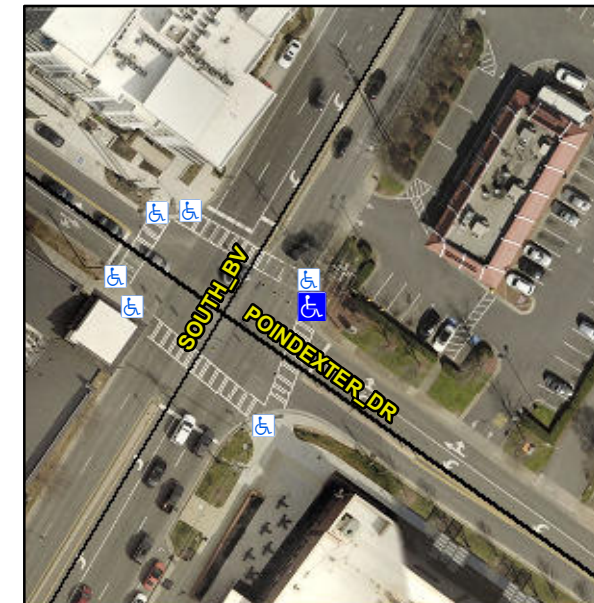
LT RP < 5%

R304.3.2

Compliance	Description	Data	Compliance	Description	Data
N/A	Ramp Length LT (in)	54.5	N/A	Ramp Length RT (in)	53.0
Yes	Ramp Width LT (in)	80.0	Yes	Ramp Width RT (in)	76.0
Yes	Ramp Slope LT (%)	4.2	No	Ramp Slope RT (%)	8.9
Yes	Ramp XSlope LT (%)	1.7	Yes	Ramp XSlope RT (%)	1.5
N/A	Landing Length (in)	N/A	N/A	DWS Provided?	N/A
N/A	Landing Width (in)	N/A	N/A	DWS Contrast?	N/A
N/A	Landing Slope (%)	N/A	N/A	DWS Length (in)	N/A
N/A	Landing X Slope (%)	N/A	N/A	DWS Full Width?	N/A
N/A	Landing Curb? (Y/N)	N/A	N/A	DWS Offset (in)	N/A
N/A	Shared Landing?	N/A			
N/A	Gutter Ponding?	N/A	N/A	Gutter Slope (%)	N/A
N/A	Gutter Lip Ht (in)	N/A	N/A	Gutter X Slope (%)	N/A
N/A	Painted X Walk1?	Yes	N/A	Painted X Walk2?	N/A
	X Walk 1 Direction	To SW		X Walk 2 Direction	N/A
N/A	X Walk 1 Width (in)	114.0	N/A	X Walk 2 Width (in)	N/A
	X Walk 1 Slope (%)	4.6		X Walk 2 Slope (%)	N/A
	X Walk 1 X Slope (%)	0.8		X Walk 2 X Slope (%)	N/A
N/A	Ramp inside XWalk1?	Yes	N/A	Ramp inside XWalk2?	N/A

Possible Solutions:

Remove & Replace Entire Ramp.
