# Access Compliance Report

## Public Rights-of-Way

### (Curb Ramps)

Intersection ID: 47854	Main Street: ADOBE_RD	Cross Street: CACTUS_VALLEY_RD	Location: NE
ADA ID: 6E0264C0C649	Ramp Type: PerpDiag	Initial Pass/Fail: Fail	Overall Compliance: No
		Severity Score: 10

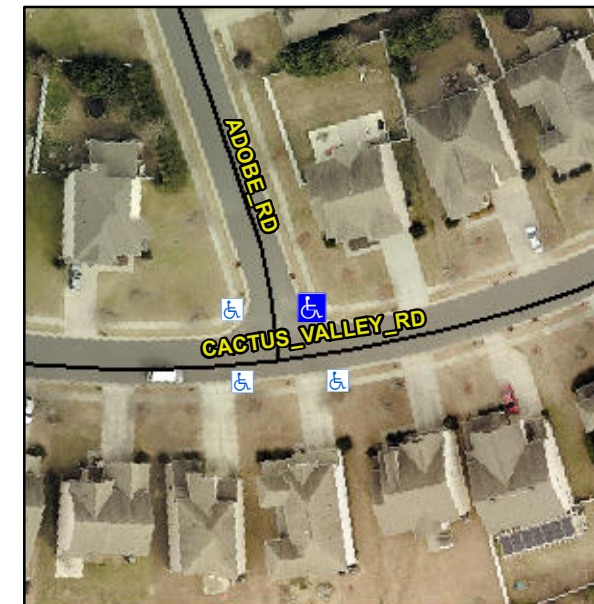
**Not Found, R304.5.1, R304.5.3**

Compliance	Description	Data	Compliance	Description	Data
N/A	Ramp Length (in)	96.0	Yes	Ramp Slope (%)	5.5
No	Ramp Width (in)	47.0	No	Ramp XSlope (%)	2.7
N/A	Flare Type LT	N/A	N/A	Flare Type RT	N/A
N/A	Flare Slope LT (%)	N/A	N/A	Flare Slope RT (%)	N/A
N/A	Flare Traversable LT?	N/A	N/A	Flare Traversable RT?	N/A
N/A	Landing Length (in)	N/A	N/A	DWS Provided?	N/A
N/A	Landing Width (in)	N/A	N/A	DWS Contrast?	N/A
N/A	Landing Slope (%)	N/A	N/A	DWS Length (in)	N/A
N/A	Landing X Slope (%)	N/A	N/A	DWS Full Width?	N/A
N/A	Landing Curb? (Y/N)	N/A	N/A	DWS Offset (in)	N/A
N/A	Shared Landing?	N/A			
N/A	Gutter Ponding?	N/A	N/A	Gutter Slope (%)	N/A
N/A	Gutter Lip Ht (in)	N/A	N/A	Gutter X Slope (%)	N/A
N/A	Painted X Walk1?	No	N/A	Painted X Walk2?	No
	X Walk 1 Direction	To W		X Walk 2 Direction	To S
N/A	X Walk 1 Width (in)	N/A	N/A	X Walk 2 Width (in)	N/A
	X Walk 1 Slope (%)	2.1		X Walk 2 Slope (%)	0.2
	X Walk 1 X Slope (%)	0.6		X Walk 2 X Slope (%)	1.3

N/A	Ramp inside XWalk1?	N/A	N/A	Ramp inside XWalk2?	N/A
	Road Slope (%)	0.1	N/A	Clear Space?	N/A
	Road X Slope (%)	1.5	N/A	Clear Space to XWalk (in)	N/A
N/A	Any Obstructions?	N/A	N/A	Storm Grate/Utility Hazard?	N/A
	Obstruction Type			Storm Grate/Utility Type	
		N/A			N/A
			Yes	Surface Condition? (G/P)	Good

**Remove & Replace Curb Ramp With Two New Directional Ramps or Equivalent.**
