Access Compliance Report

Public Rights-of-Way

(Curb Ramps)

Intersection ID: 23309	Main Street: BRIDGEWOOD_LN	Cross Street: CARMEL_RD	Location: E
ADA ID: 6E1AC8CF553F	Ramp Type: PerpDiag	Initial Pass/Fail: Fail	Overall Compliance: No
		Severity Score: 37.5

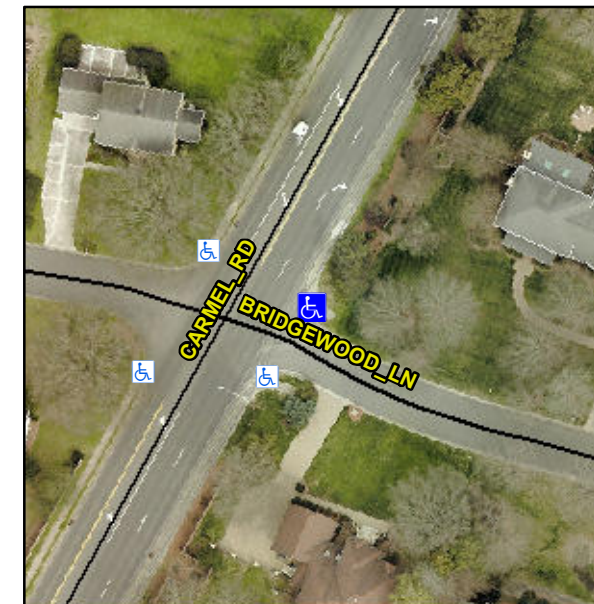
R304.2.2, R304.5.3

Compliance	Description	Data	Compliance	Description	Data
N/A	Ramp Length (in)	99.0	No	Ramp Slope (%)	11.1
Yes	Ramp Width (in)	48.0	No	Ramp XSlope (%)	8.6
N/A	Flare Type LT	N/A	N/A	Flare Type RT	N/A
N/A	Flare Slope LT (%)	N/A	N/A	Flare Slope RT (%)	N/A
N/A	Flare Traversable LT?	N/A	N/A	Flare Traversable RT?	N/A
N/A	Landing Length (in)	N/A	N/A	DWS Provided?	N/A
N/A	Landing Width (in)	N/A	N/A	DWS Contrast?	N/A
N/A	Landing Slope (%)	N/A	N/A	DWS Length (in)	N/A
N/A	Landing X Slope (%)	N/A	N/A	DWS Full Width?	N/A
N/A	Landing Curb? (Y/N)	N/A	N/A	DWS Offset (in)	N/A
N/A	Shared Landing?	N/A			
N/A	Gutter Ponding?	N/A	N/A	Gutter Slope (%)	N/A
N/A	Gutter Lip Ht (in)	N/A	N/A	Gutter X Slope (%)	N/A
N/A	Painted X Walk1?	No	N/A	Painted X Walk2?	No
	X Walk 1 Direction	To NW		X Walk 2 Direction	To SW
N/A	X Walk 1 Width (in)	N/A	N/A	X Walk 2 Width (in)	N/A
	X Walk 1 Slope (%)	3.5		X Walk 2 Slope (%)	1.4
	X Walk 1 X Slope (%)	1.7		X Walk 2 X Slope (%)	4.3

N/A	Ramp inside XWalk1?	N/A	N/A	Ramp inside XWalk2?	N/A
	Road Slope (%)	1.5	N/A	Clear Space?	N/A
	Road X Slope (%)	6.3	N/A	Clear Space to XWalk (in)	N/A
N/A	Any Obstructions?	N/A	N/A	Storm Grate/Utility Hazard?	N/A
	Obstruction Type			Storm Grate/Utility Type	
		N/A			N/A
			Yes	Surface Condition? (G/P)	Good

Remove & Replace Curb Ramp With Two New Directional Ramps or Equivalent.
