Access Compliance Report

Public Rights-of-Way

(Curb Ramps)

Intersection ID: 3840	Main Street: CHIMNEY RIDGE TL	Cross Street: DEER CROSS TL	Location:	NW
ADA ID: 6E20DCDA5521	Ramp Type: Perp	Initial Pass/Fail: Fail	Overall Compliance: No	Severity Score: 10

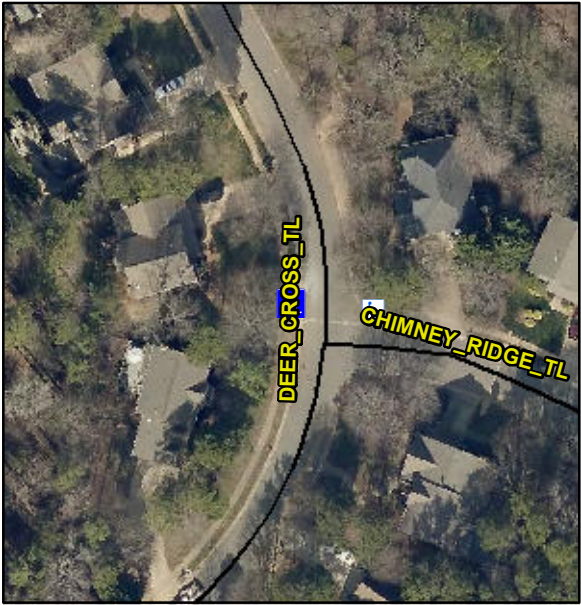
Possible Solutions:		Compliance	Description	Data
	Remove & Replace Entire Ramp.		Yes	Ramp Slope (%)	6.1
			No	Ramp XSlope (%)	3.9
			N/A	Flare Type LT	N/A
			N/A	Flare Slope LT (%)	N/A
			N/A	Flare Traversable LT?	N/A
			N/A	Flare Traversable RT?	N/A
			N/A	DWS Provided?	N/A
			N/A	DWS Contrast?	N/A
			N/A	DWS Length (in)	N/A
<p>Surveyor Notes:</p> <p>N/A</p> <p>PROW/ADA:</p> <p>Not Found, R304.5.1, R304.5.3</p>			N/A	DWS Full Width?	N/A
			N/A	DWS Offset (in)	N/A
			N/A	Shared Landing?	N/A
			N/A	Gutter Ponding?	N/A
			N/A	Gutter Lip Ht (in)	N/A
			N/A	Painted X Walk1?	N/A
			N/A	X Walk 1 Direction	N/A
			N/A	X Walk 1 Width (in)	N/A
			N/A	X Walk 1 Slope (%)	N/A
			N/A	X Walk 1 X Slope (%)	N/A
<p>Total Cost:</p> <p>\$ 1850.00</p>			No	Painted X Walk2?	N/A
			To E	X Walk 2 Direction	N/A
			N/A	X Walk 2 Width (in)	N/A

5.2	X Walk 2 Slope (%)	N/A
			3.4	X Walk 2 X Slope (%)	N/A
			N/A	Ramp inside XWalk1?	N/A
			N/A	Ramp inside XWalk2?	N/A
			N/A	Road Slope (%)	N/A
			N/A	Road X Slope (%)	N/A
			N/A	Any Obstructions?	N/A
			N/A	Obstruction Type	N/A
			N/A	Storm Grate/Utility Hazard?	N/A
			N/A	Storm Grate/Utility Type	N/A
			N/A	Surface Condition? (G/P)	Good
			N/A		
			N/A		
			N/A		
			N/A		
			N/A		
			N/A
