Access Compliance Report

Public Rights-of-Way

(Curb Ramps)

Intersection ID: 50603	Main Street: RHODORA_RD	Cross Street: EMPRESS_CT	Location: NW
ADA ID: 6E2FB417E2F3	Ramp Type: Perp	Initial Pass/Fail: Fail	Overall Compliance: No
Severity Score: 10			
Codes/Mitigation Info/Possible Solution		Field Measurements/Component Compliance

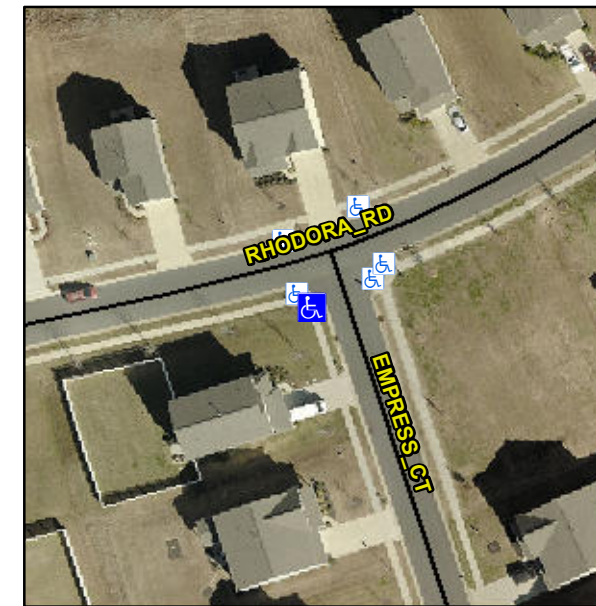
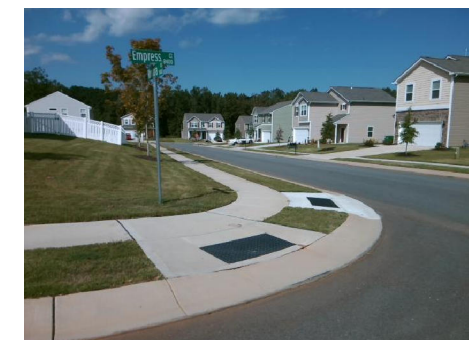
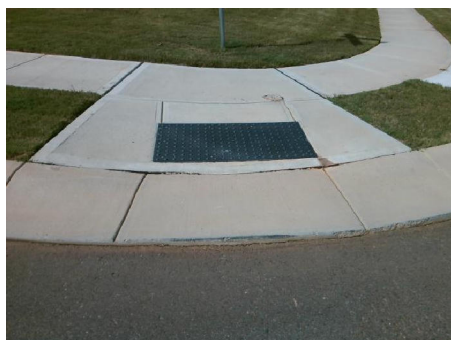
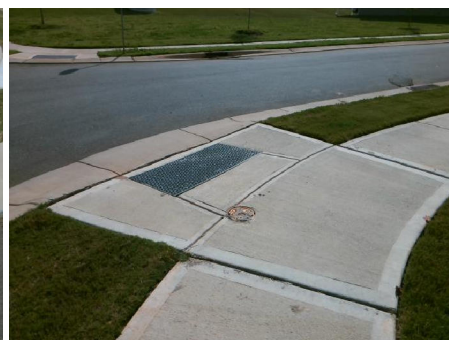
R304.5.1, R304.5.3

Compliance	Description	Data	Compliance	Description	Data
N/A	Ramp Length (in)	48.5	Yes	Ramp Slope (%)	7.3
No	Ramp Width (in)	46.0	No	Ramp XSlope (%)	4.2
N/A	Flare Type LT	N/A	N/A	Flare Type RT	N/A
N/A	Flare Slope LT (%)	N/A	N/A	Flare Slope RT (%)	N/A
N/A	Flare Traversable LT?	N/A	N/A	Flare Traversable RT?	N/A
N/A	Landing Length (in)	N/A	N/A	DWS Provided?	N/A
N/A	Landing Width (in)	N/A	N/A	DWS Contrast?	N/A
N/A	Landing Slope (%)	N/A	N/A	DWS Length (in)	N/A
N/A	Landing X Slope (%)	N/A	N/A	DWS Full Width?	N/A
N/A	Landing Curb? (Y/N)	N/A	N/A	DWS Offset (in)	N/A
N/A	Shared Landing?	N/A			
N/A	Gutter Ponding?	N/A	N/A	Gutter Slope (%)	N/A
N/A	Gutter Lip Ht (in)	N/A	N/A	Gutter X Slope (%)	N/A
N/A	Painted X Walk1?	No	N/A	Painted X Walk2?	N/A
	X Walk 1 Direction	To E		X Walk 2 Direction	N/A
N/A	X Walk 1 Width (in)	N/A	N/A	X Walk 2 Width (in)	N/A
	X Walk 1 Slope (%)	2.3		X Walk 2 Slope (%)	N/A
	X Walk 1 X Slope (%)	3.4		X Walk 2 X Slope (%)	N/A

N/A	Ramp inside XWalk1?	N/A	N/A	Ramp inside XWalk2?	N/A
	Road Slope (%)	N/A	N/A	Clear Space?	N/A
	Road X Slope (%)	N/A	N/A	Clear Space to XWalk (in)	N/A
N/A	Any Obstructions?	N/A	N/A	Storm Grate/Utility Hazard?	N/A
	Obstruction Type			Storm Grate/Utility Type	
		N/A			N/A
			Yes	Surface Condition? (G/P)	Good

Possible Solutions:

Remove & Replace Entire Ramp.

Total Cost: \$ 1850.00
