Intersection ID: 13416	Main Street: CENTRAL_AV	Cross Street: MASONIC_DR	Location:	E
ADA ID: 6E3767A33F53	Ramp Type: BlendTrans1	Initial Pass/Fail: Fail	Overall Compliance: No	Severity Score: 35

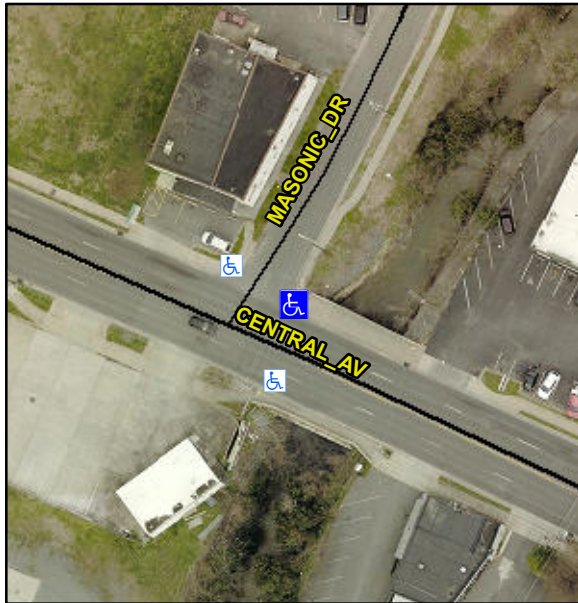
Not Found, R304.5.1

Compliance	Description	Data	Compliance	Description	Data
N/A	Ramp Length (in)	74.0	Yes	BlendTrans Slope (%)	2.7
No	Ramp Width (in)	24.0	Yes	BlendTrans XSlope (%)	1.9
N/A	Flare Type LT	N/A	N/A	Flare Type RT	N/A
N/A	Flare Slope LT (%)	N/A	N/A	Flare Slope RT (%)	N/A
N/A	Flare Traversable LT?	N/A	N/A	Flare Traversable RT?	N/A
N/A	Landing Length (in)	N/A	N/A	DWS Provided?	N/A
N/A	Landing Width (in)	N/A	N/A	DWS Contrast?	N/A
N/A	Landing Slope (%)	N/A	N/A	DWS Length (in)	N/A
N/A	Landing X Slope (%)	N/A	N/A	DWS Full Width?	N/A
N/A	Landing Curb? (Y/N)	N/A	N/A	DWS Offset (in)	N/A
N/A	Shared Landing?	N/A			
N/A	Gutter Ponding?	N/A	N/A	Gutter Slope (%)	N/A
N/A	Gutter Lip Ht (in)	N/A	N/A	Gutter X Slope (%)	N/A
N/A	Painted X Walk1?	No	N/A	Painted X Walk2?	No
	X Walk 1 Direction	To NW		X Walk 2 Direction	To SW
	X Walk 1 Width (in)	N/A		X Walk 2 Width (in)	N/A
	X Walk 1 Slope (%)	2.2		X Walk 2 Slope (%)	5.8
	X Walk 1 X Slope (%)	4.6		X Walk 2 X Slope (%)	2.1

N/A	Ramp inside XWalk1?	N/A	N/A	Ramp inside XWalk2?	N/A
	Road Slope (%)	4.1		Clear Space?	N/A
	Road X Slope (%)	7.7	N/A	Clear Space to XWalk (in)	N/A
N/A	Any Obstructions?	N/A	N/A	Storm Grate/Utility Hazard?	N/A
	Obstruction Type			Storm Grate/Utility Type	
		N/A			N/A
			Yes	Surface Condition? (G/P)	Good
			No	Curb Slope (%)	18.9

Remove & Replace Curb Ramp With Two New Directional Ramps or Equivalent.

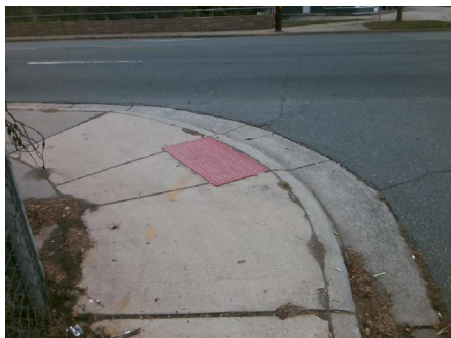
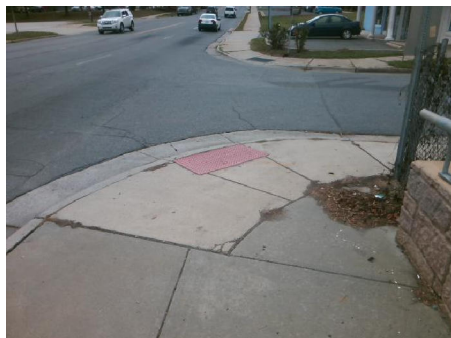
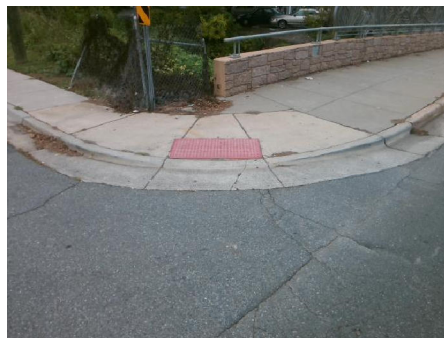
Street 1 Name	MASONIC DR
Stop Condition-Street 1	StopSign
Street 2 Name	CENTRAL AV
Stop Condition-Street 2	None
