Access Compliance Report

Public Rights-of-Way

(Curb Ramps)

Intersection ID: 46144	Main Street: EASTFIELD_VILLAGE_LN	Cross Street: ROCKY_FORD_CLUB_RD	Location: E
ADA ID: 6E477A5BDC03	Ramp Type: Perp	Initial Pass/Fail: Fail	Overall Compliance: No
Severity Score: 36.25			
Codes/Mitigation Info/Possible Solution		Field Measurements/Component Compliance

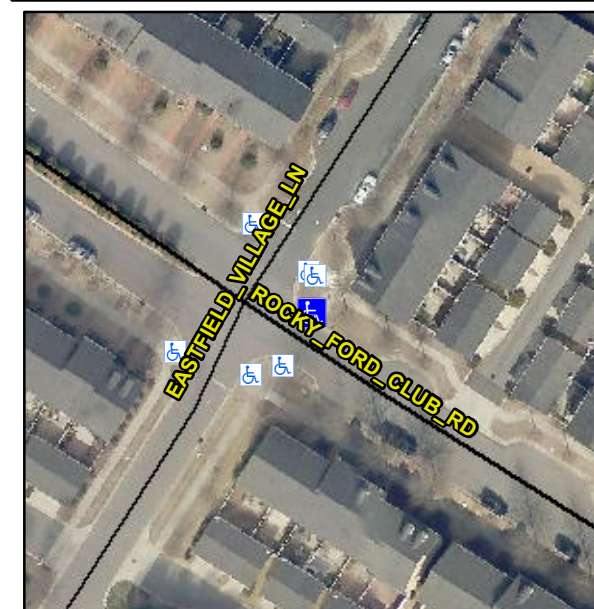
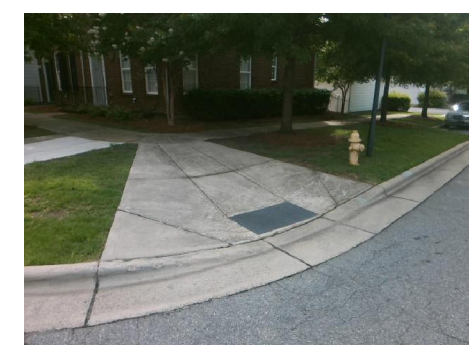
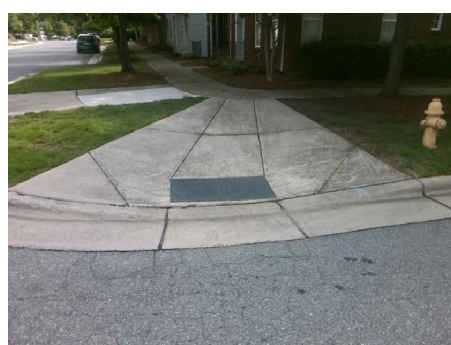
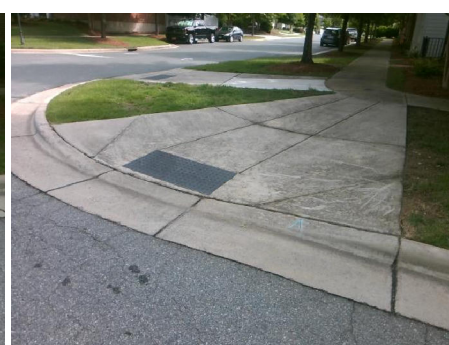
Compliance	Description	Data	Compliance	Description	Data
N/A	Ramp Length (in)	198.0	Yes	Ramp Slope (%)	7.2
No	Ramp Width (in)	25.0	No	Ramp XSlope (%)	4.7
N/A	Flare Type LT	N/A	N/A	Flare Type RT	N/A
N/A	Flare Slope LT (%)	N/A	N/A	Flare Slope RT (%)	N/A
N/A	Flare Traversable LT?	N/A	N/A	Flare Traversable RT?	N/A
N/A	Landing Length (in)	N/A	N/A	DWS Provided?	N/A
N/A	Landing Width (in)	N/A	N/A	DWS Contrast?	N/A
N/A	Landing Slope (%)	N/A	N/A	DWS Length (in)	N/A
N/A	Landing X Slope (%)	N/A	N/A	DWS Full Width?	N/A
N/A	Landing Curb? (Y/N)	N/A	N/A	DWS Offset (in)	N/A
N/A	Shared Landing?	N/A			
N/A	Gutter Ponding?	N/A	N/A	Gutter Slope (%)	N/A
N/A	Gutter Lip Ht (in)	N/A	N/A	Gutter X Slope (%)	N/A
N/A	Painted X Walk1?	No	N/A	Painted X Walk2?	N/A
	X Walk 1 Direction	To SW		X Walk 2 Direction	N/A
N/A	X Walk 1 Width (in)	N/A	N/A	X Walk 2 Width (in)	N/A
	X Walk 1 Slope (%)	4.5		X Walk 2 Slope (%)	N/A
	X Walk 1 X Slope (%)	3.6		X Walk 2 X Slope (%)	N/A

N/A	Ramp inside XWalk1?	N/A	N/A	Ramp inside XWalk2?	N/A
	Road Slope (%)	N/A	N/A	Clear Space?	N/A
	Road X Slope (%)	N/A	N/A	Clear Space to XWalk (in)	N/A
N/A	Any Obstructions?	N/A	N/A	Storm Grate/Utility Hazard?	N/A
	Obstruction Type			Storm Grate/Utility Type	
		N/A			N/A
			Yes	Surface Condition? (G/P)	Good

Remove & Replace Entire Ramp.

R304.5.1, R304.5.3
