Access Compliance Report

Public Rights-of-Way

(Curb Ramps)

Intersection ID: 10825	Main Street: E_26TH_ST	Cross Street: N_DAVIDSON_ST	Location: W
ADA ID: 6E5173A87C7F	Ramp Type: Directional1	Initial Pass/Fail: Fail	Overall Compliance: No
		Severity Score: 10

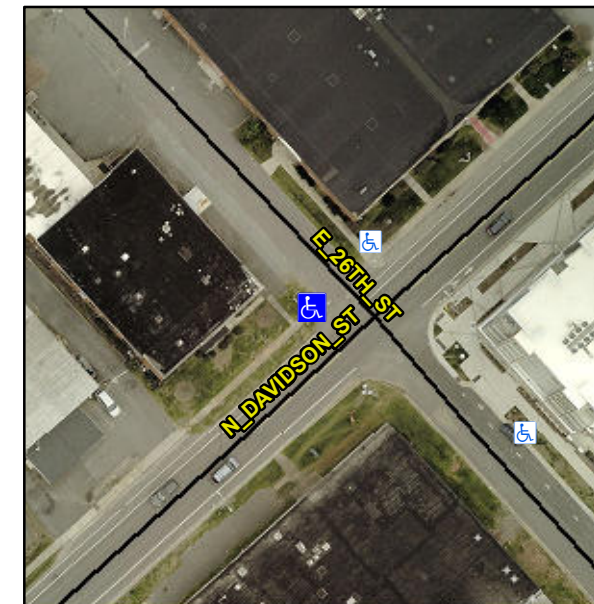
NO CURB

Compliance	Description	Data	Compliance	Description	Data
N/A	Ramp Length (in)	250.0	N/A	Grade Break?	N/A
No	Ramp Width (in)	47.0	N/A	Grade Break Slope (%)	0.0
Yes	Ramp Slope (%)	6.3	N/A	Grade Break XSlope (%)	0.0
No	Ramp XSlope (%)	3.0			
N/A	Flare Type LT	N/A	N/A	Flare Type RT	N/A
N/A	Flare Slope LT (%)	N/A	N/A	Flare Slope RT (%)	0.0
N/A	Flare Traversable LT?	N/A	N/A	Flare Traversable RT?	N/A
N/A	Landing Length (in)	0.0	N/A	DWS Provided?	N/A
N/A	Landing Width (in)	0.0	N/A	DWS Contrast?	N/A
N/A	Landing Slope (%)	0.0	N/A	DWS Length (in)	N/A
N/A	Landing X Slope (%)	0.0	N/A	DWS Full Width?	N/A
N/A	Landing Curb? (Y/N)	N/A	N/A	DWS Offset LT (in)	N/A
N/A	Shared Landing?	N/A	N/A	DWS Offset RT (in)	N/A
N/A	Gutter Ponding?	0.0	N/A	Gutter Slope (%)	N/A
N/A	Gutter Lip Ht (in)	0.0	N/A	Gutter X Slope (%)	N/A
N/A	Painted X Walk1?	No		Road Slope (%)	1.2
	X Walk 1 Direction	To NE		Road X Slope (%)	3.7
	X Walk 1 Width (in)	N/A		Clear Space?	N/A

X Walk 1 Slope (%)	1.2	N/A	Clear Space to XWalk (in)	N/A
	X Walk 1 X Slope (%)	3.7	N/A	Storm Grate/Utility Hazard?	N/A
N/A	Ramp inside XWalk1?	N/A		Storm Grate/Utility Type	
N/A	Any Obstructions?	N/A			N/A
	Obstruction Type		Yes	Surface Condition? (G/P)	Good
			N/A	Curb Slope (%)	N/A

Remove & Replace Entire Ramp.
