## **Access Compliance Report Public Rights-of-Way** (Curb Ramps)

Intersection ID: 11227 Main Street: N\_GRAHAM\_ST Cross Street: NC\_MUSIC\_FACTORY\_BV Location: NW ADA ID: 6E59E227A011 Ramp Type: Perp Initial Pass/Fail: Fail **Overall Compliance: No Severity Score:** 12.5

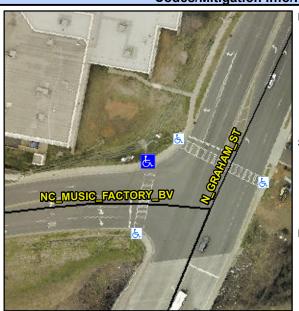
Field Measurements/Component Compliance							
Compl	iance Description	Data	Comp	liance Description	Data		
N/A	Ramp Length (in)	72.0	No	Ramp Slope (%)	9.0		
Yes	Ramp Width (in)	48.0	Yes	Ramp XSlope (%)	1.2		
N/A	Flare Type LT	N/A	N/A	Flare Type RT	N/A		
N/A	Flare Slope LT (%)	N/A	N/A	Flare Slope RT (%)	N/A		
N/A	Flare Traversable LT?	N/A	N/A	Flare Traversable RT?	N/A		
N/A	Landing Length (in)	N/A	N/A	DWS Provided?	N/A		
N/A	Landing Width (in)	N/A	N/A	DWS Contrast?	N/A		
N/A	Landing Slope (%)	N/A	N/A	DWS Length (in)	N/A		
N/A	Landing X Slope (%)	N/A	N/A	DWS Full Width?	N/A		
N/A	Landing Curb? (Y/N)	N/A	N/A	DWS Offset (in)	N/A		
N/A	Shared Landing?	N/A					
N/A	Gutter Ponding?	N/A	N/A	Gutter Slope (%)	N/A		
N/A	Gutter Lip Ht (in)	N/A	N/A	Gutter X Slope (%)	N/A		
N/A	Painted X Walk1?	Yes	N/A	Painted X Walk2?	N/A		
	X Walk 1 Direction	To S		X Walk 2 Direction	N/A		
N/A	X Walk 1 Width (in)	114.0	N/A	X Walk 2 Width (in)	N/A

X Walk 1 Slope (%)	3.9		X Walk 2 Slope (%)	N/A		
	X Walk 1 X Slope (%)	0.8		X Walk 2 X Slope (%)	N/A		
N/A	Ramp inside XWalk1?	Yes	N/A	Ramp inside XWalk2?	N/A		
	Road Slope (%)	N/A	N/A	Clear Space?	N/A		
	Road X Slope (%)	N/A	N/A	Clear Space to XWalk (in)	N/A		
N/A	Any Obstructions?	N/A	N/A	Storm Grate/Utility Hazard?	N/A		
	Obstruction Type			Storm Grate/Utility Type			
		N/A			N/A		
			Yes	Surface Condition? (G/P)	Good

Possible Solutions:	<u>c</u>
Remove & Replace Entire Ramp.	N.
•	Y
	N
	N
	N
	N
Surveyor Notes:	N
N/A	N
	N.
	N
	N
PROW/ADA:	N
Not Found, R304.2.2	N.
	N
	N

Total Cost:	\$ 1850.00
