# Access Compliance Report

## Public Rights-of-Way

### (Curb Ramps)

Intersection ID: 10033070	Main Street: NORTH_COMMUNITY_HOUSE_RD	Cross Street: N/A	Location: SW
ADA ID: 6E66D3BD7259	Ramp Type: PerpDiag	Initial Pass/Fail: Fail	Overall Compliance: No
Severity Score: 8.75			
Codes/Mitigation Info/Possible Solution		Field Measurements/Component Compliance

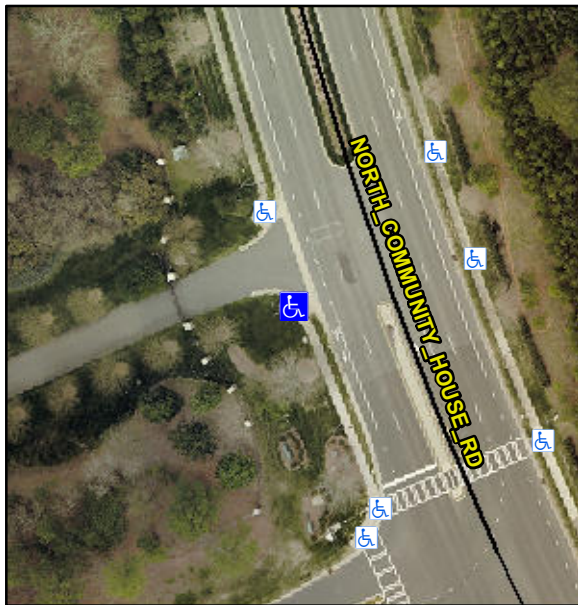
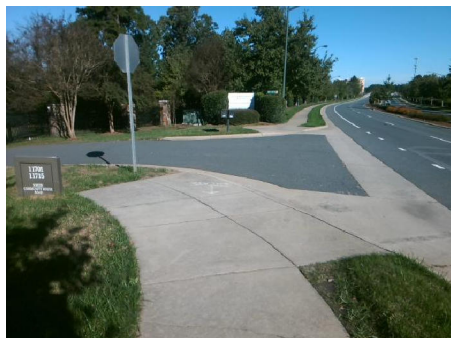
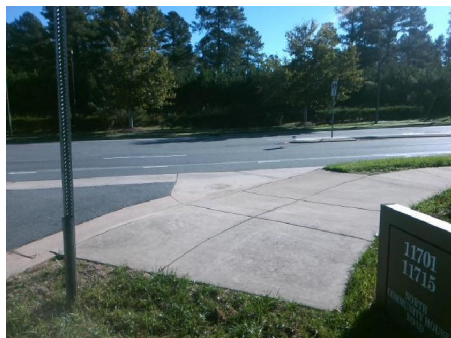
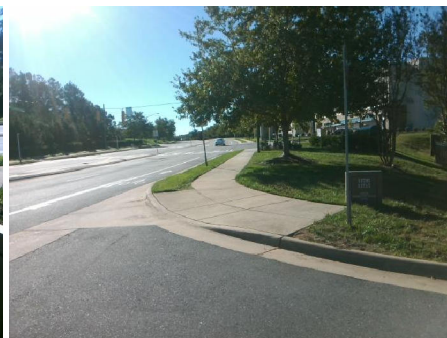
**Not Found, R304.5.1**

Compliance	Description	Data	Compliance	Description	Data
N/A	Ramp Length (in)	108.0	Yes	Ramp Slope (%)	5.1
No	Ramp Width (in)	41.0	Yes	Ramp XSlope (%)	1.6
N/A	Flare Type LT	N/A	N/A	Flare Type RT	N/A
N/A	Flare Slope LT (%)	N/A	N/A	Flare Slope RT (%)	N/A
N/A	Flare Traversable LT?	N/A	N/A	Flare Traversable RT?	N/A
N/A	Landing Length (in)	N/A	N/A	DWS Provided?	N/A
N/A	Landing Width (in)	N/A	N/A	DWS Contrast?	N/A
N/A	Landing Slope (%)	N/A	N/A	DWS Length (in)	N/A
N/A	Landing X Slope (%)	N/A	N/A	DWS Full Width?	N/A
N/A	Landing Curb? (Y/N)	N/A	N/A	DWS Offset (in)	N/A
N/A	Shared Landing?	N/A			
N/A	Gutter Ponding?	N/A	N/A	Gutter Slope (%)	N/A
N/A	Gutter Lip Ht (in)	N/A	N/A	Gutter X Slope (%)	N/A
N/A	Painted X Walk1?	No	N/A	Painted X Walk2?	No
	X Walk 1 Direction	To NE		X Walk 2 Direction	To NW
N/A	X Walk 1 Width (in)	N/A	N/A	X Walk 2 Width (in)	N/A
	X Walk 1 Slope (%)	4.8		X Walk 2 Slope (%)	2.4
	X Walk 1 X Slope (%)	0.4		X Walk 2 X Slope (%)	1.6

N/A	Ramp inside XWalk1?	N/A	N/A	Ramp inside XWalk2?	N/A
	Road Slope (%)	5.0	N/A	Clear Space?	N/A
	Road X Slope (%)	0.3	N/A	Clear Space to XWalk (in)	N/A
N/A	Any Obstructions?	N/A	N/A	Storm Grate/Utility Hazard?	N/A
	Obstruction Type			Storm Grate/Utility Type	
		N/A			N/A
			Yes	Surface Condition? (G/P)	Good

**Remove & Replace Curb Ramp With Two New Directional Ramps or Equivalent.**
