Access Compliance Report

Public Rights-of-Way

(Curb Ramps)

Intersection ID: 5749	Main Street: NEVIN_RD	Cross Street: WHITE_PINE_LN	Location: SW
ADA ID: 6E67861A4A76	Ramp Type: Perp	Initial Pass/Fail: Fail	Overall Compliance: No
		Severity Score: 21.25

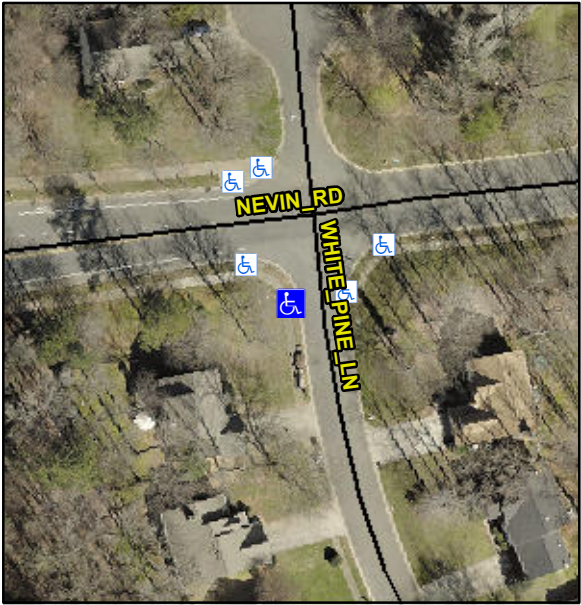
Possible Solutions:						
	Remove & Replace Entire Ramp.						
	Surveyor Notes:						
	N/A						
	PROW/ADA:						
	Not Found, R304.5.1, R304.5.3						
		Compliance	Description	Data	Compliance	Description	Data
		N/A	Ramp Length (in)	49.0	Yes	Ramp Slope (%)	7.1
		No	Ramp Width (in)	45.0	No	Ramp XSlope (%)	6.5
		N/A	Flare Type LT	N/A	N/A	Flare Type RT	N/A
		N/A	Flare Slope LT (%)	N/A	N/A	Flare Slope RT (%)	N/A
		N/A	Flare Traversable LT?	N/A	N/A	Flare Traversable RT?	N/A
		N/A	Landing Length (in)	N/A	N/A	DWS Provided?	N/A
		N/A	Landing Width (in)	N/A	N/A	DWS Contrast?	N/A
		N/A	Landing Slope (%)	N/A	N/A	DWS Length (in)	N/A
		N/A	Landing X Slope (%)	N/A	N/A	DWS Full Width?	N/A
		N/A	Landing Curb? (Y/N)	N/A	N/A	DWS Offset (in)	N/A
		N/A	Shared Landing?	N/A			
		N/A	Gutter Ponding?	N/A	N/A	Gutter Slope (%)	N/A
		N/A	Gutter Lip Ht (in)	1.5	N/A	Gutter X Slope (%)	N/A

N/A	Painted X Walk1?	No	N/A	Painted X Walk2?	N/A
			X Walk 1 Direction	To E		X Walk 2 Direction	N/A
		N/A	X Walk 1 Width (in)	N/A	N/A	X Walk 2 Width (in)	N/A
			X Walk 1 Slope (%)	3.1		X Walk 2 Slope (%)	N/A
			X Walk 1 X Slope (%)	5.2		X Walk 2 X Slope (%)	N/A
		N/A	Ramp inside XWalk1?	N/A	N/A	Ramp inside XWalk2?	N/A
			Road Slope (%)	N/A	N/A	Clear Space?	N/A
			Road X Slope (%)	N/A	N/A	Clear Space to XWalk (in)	N/A
		N/A	Any Obstructions?	N/A	N/A	Storm Grate/Utility Hazard?	N/A
			Obstruction Type			Storm Grate/Utility Type	
Total Cost:		\$	1850.00				
				N/A			N/A
				Yes		Surface Condition? (G/P)	Good
