Access Compliance Report Public Rights-of-Way (Curb Ramps)

Intersection ID: 42358 Main Street: KESTRAL_RIDGE_DR Cross Street: WRENS_NEST_LN Location: NW
ADA ID: 6E77EF8CD252 Ramp Type: BlendTrans1 Initial Pass/Fail: Fail Overall Compliance: No Severity Score: 25

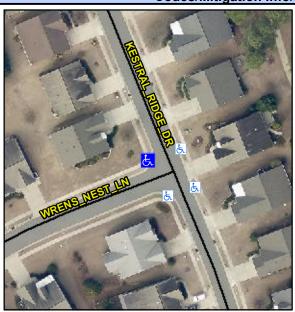
Compliance Description		Data	Compliance Description		Data
N	A Ramp Length (in)	47.0	Yes	BlendTrans Slope (%)	3.2
Ye	es Ramp Width (in)	48.0	No	BlendTrans XSlope (%)	8.2
N	A Flare Type LT	N/A	N/A	Flare Type RT	N/A
N	A Flare Slope LT (%)	N/A	N/A	Flare Slope RT (%)	N/A
N	A Flare Traversable LT?	N/A	N/A	Flare Traversable RT?	N/A

Remove & Replace Curb Ramp With
Two New Directional Ramps or
Equivalent.

PROW/ADA:
R304.5.3
