# Access Compliance Report

## Public Rights-of-Way

### (Curb Ramps)

Intersection ID: 30117	Main Street: CLOONEY_LN	Cross Street: DAVIS_FOREST_LN	Location: N
ADA ID: 6E80B97E6C67	Ramp Type: PerpDiag	Initial Pass/Fail: Fail	Overall Compliance: No
		Severity Score: 8.75

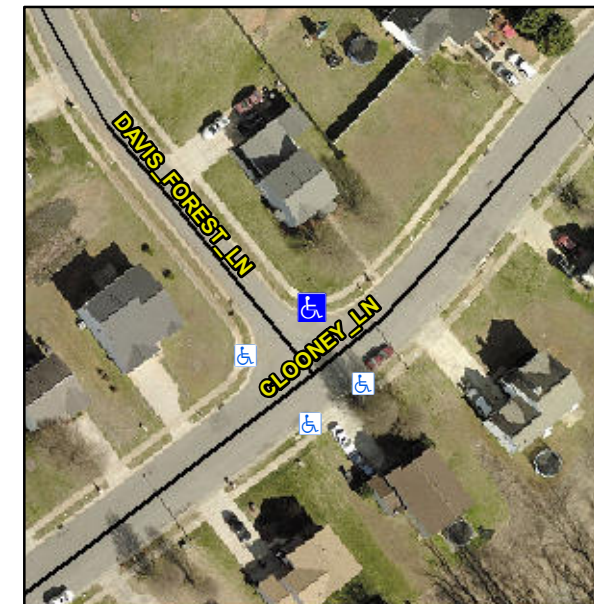
Compliance	Description	Data	Compliance	Description	Data
N/A	Ramp Length (in)	45.0	Yes	Ramp Slope (%)	8.1
No	Ramp Width (in)	41.0	Yes	Ramp XSlope (%)	0.7
N/A	Flare Type LT	N/A	N/A	Flare Type RT	N/A
N/A	Flare Slope LT (%)	N/A	N/A	Flare Slope RT (%)	N/A
N/A	Flare Traversable LT?	N/A	N/A	Flare Traversable RT?	N/A
N/A	Landing Length (in)	N/A	N/A	DWS Provided?	N/A
N/A	Landing Width (in)	N/A	N/A	DWS Contrast?	N/A
N/A	Landing Slope (%)	N/A	N/A	DWS Length (in)	N/A
N/A	Landing X Slope (%)	N/A	N/A	DWS Full Width?	N/A
N/A	Landing Curb? (Y/N)	N/A	N/A	DWS Offset (in)	N/A
N/A	Shared Landing?	N/A			
N/A	Gutter Ponding?	Yes	N/A	Gutter Slope (%)	N/A
N/A	Gutter Lip Ht (in)	N/A	N/A	Gutter X Slope (%)	N/A
N/A	Painted X Walk1?	No	N/A	Painted X Walk2?	No
	X Walk 1 Direction	To SW		X Walk 2 Direction	To S
N/A	X Walk 1 Width (in)	N/A	N/A	X Walk 2 Width (in)	N/A
	X Walk 1 Slope (%)	2.2		X Walk 2 Slope (%)	0.3
	X Walk 1 X Slope (%)	2.4		X Walk 2 X Slope (%)	0.7

N/A	Ramp inside XWalk1?	N/A	N/A	Ramp inside XWalk2?	N/A
	Road Slope (%)	0.5	N/A	Clear Space?	N/A
	Road X Slope (%)	0.2	N/A	Clear Space to XWalk (in)	N/A
N/A	Any Obstructions?	N/A	N/A	Storm Grate/Utility Hazard?	N/A
	Obstruction Type			Storm Grate/Utility Type	
		N/A			N/A
		Yes		Surface Condition? (G/P)	Good

**Remove & Replace Curb Ramp With Two New Directional Ramps or Equivalent.**

**R304.5.1**

Total Cost: \$ 3200.00
