# Access Compliance Report

## Public Rights-of-Way

### (Curb Ramps)

| Intersection ID: 25177 | Main Street: CARMEL_RD | Cross Street: MEADOWRIDGE_DR | Location: SW |

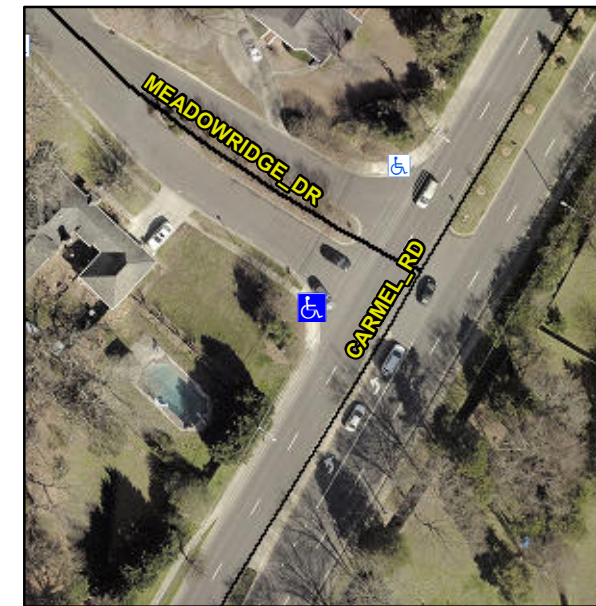
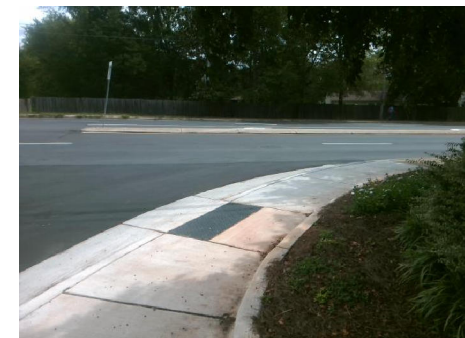
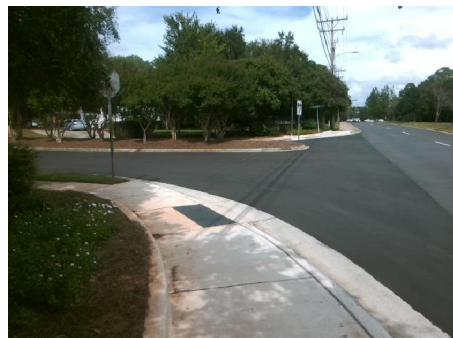
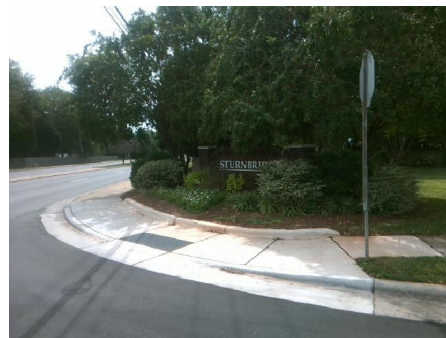
| ADA ID: 6E835B2F3D10 | Ramp Type: BlendTrans2 | Initial Pass/Fail: Pass | Overall Compliance: No |

| Compliance | Description | Data | Compliance | Description | Data |
|---|---|---|---|---|---|
| | | | No | Curb Slope (%) | 5.9 |

**Remove & Replace Curb Slope and Extend Ramp.**

Total Cost: \$ 2000.00
