Intersection ID: 51071	Main Street: KEMPSFORD_DR	Cross Street: GRICKLADE_DR	Location:	SW
ADA ID: 6E89AE688DB8	Ramp Type: PerpDiag	Initial Pass/Fail: Fail	Overall Compliance: No	Severity Score: 13.75

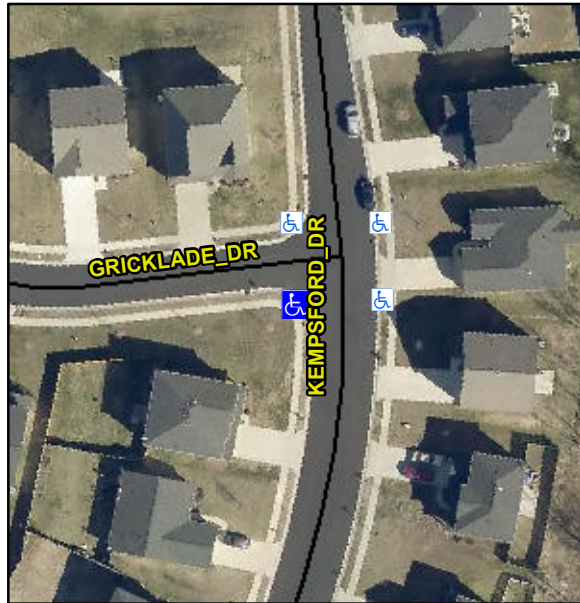
Not Found, R304.2.2, R304.5.3

Compliance	Description	Data	Compliance	Description	Data
N/A	Ramp Length (in)	48.0	No	Ramp Slope (%)	9.4
Yes	Ramp Width (in)	48.2	No	Ramp XSlope (%)	2.7
N/A	Flare Type LT	N/A	N/A	Flare Type RT	N/A
N/A	Flare Slope LT (%)	N/A	N/A	Flare Slope RT (%)	N/A
N/A	Flare Traversable LT?	N/A	N/A	Flare Traversable RT?	N/A
N/A	Landing Length (in)	N/A	N/A	DWS Provided?	N/A
N/A	Landing Width (in)	N/A	N/A	DWS Contrast?	N/A
N/A	Landing Slope (%)	N/A	N/A	DWS Length (in)	N/A
N/A	Landing X Slope (%)	N/A	N/A	DWS Full Width?	N/A
N/A	Landing Curb? (Y/N)	N/A	N/A	DWS Offset (in)	N/A
N/A	Shared Landing?	N/A			
N/A	Gutter Ponding?	N/A	N/A	Gutter Slope (%)	N/A
N/A	Gutter Lip Ht (in)	N/A	N/A	Gutter X Slope (%)	N/A
N/A	Painted X Walk1?	No	N/A	Painted X Walk2?	No
	X Walk 1 Direction	To E		X Walk 2 Direction	To N
N/A	X Walk 1 Width (in)	N/A	N/A	X Walk 2 Width (in)	N/A
	X Walk 1 Slope (%)	1.7		X Walk 2 Slope (%)	0.6
	X Walk 1 X Slope (%)	0.6		X Walk 2 X Slope (%)	1.4

N/A	Ramp inside XWalk1?	N/A	N/A	Ramp inside XWalk2?	N/A
	Road Slope (%)	2.2	N/A	Clear Space?	N/A
	Road X Slope (%)	1.3	N/A	Clear Space to XWalk (in)	N/A
N/A	Any Obstructions?	N/A	N/A	Storm Grate/Utility Hazard?	N/A
	Obstruction Type			Storm Grate/Utility Type	
		N/A			N/A
			Yes	Surface Condition? (G/P)	Good

Possible Solutions:

Remove & Replace Curb Ramp With Two New Directional Ramps or Equivalent.
