Access Compliance Report

Public Rights-of-Way

(Curb Ramps)

Intersection ID: 9974	Main Street: EDGEWOOD_RD	Cross Street: QUEEN_CITY_DR	Location: SW
ADA ID: 6EA107D3DAC2	Ramp Type: PerpDiag	Initial Pass/Fail: Fail	Overall Compliance: No
			Severity Score: 21.25

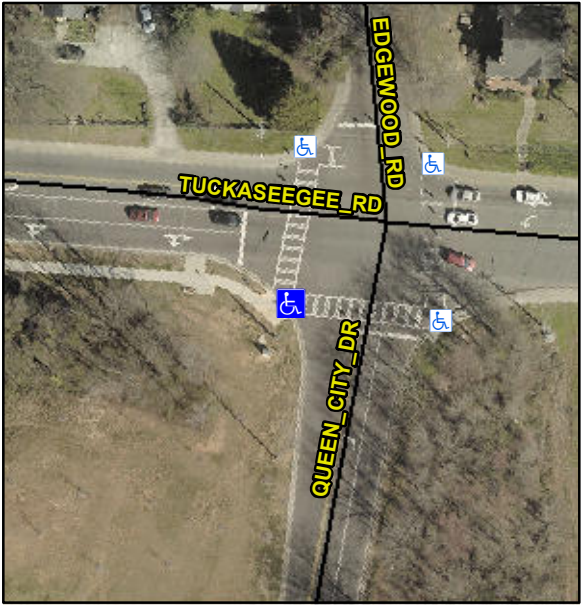
Possible Solutions:		Compliance	Description	Data
	Remove & Replace Curb Ramp With Two New Directional Ramps or Equivalent.		No	Ramp Length (in)	62.0
			No	Ramp Width (in)	46.5
			N/A	Flare Type LT	N/A
			N/A	Flare Slope LT (%)	N/A
			N/A	Flare Traversable LT?	N/A
			N/A	Landing Length (in)	N/A
			N/A	Landing Width (in)	N/A
			N/A	Landing Slope (%)	N/A
			N/A	Landing X Slope (%)	N/A
<p>Surveyor Notes:</p> <p>N/A</p> <p>PROW/ADA:</p> <p>Not Found, R304.5.1, R304.2.2</p>			N/A	Flare Type RT	N/A
			N/A	Flare Slope RT (%)	N/A
			N/A	Flare Traversable RT?	N/A
			N/A	DWS Provided?	N/A
			N/A	DWS Contrast?	N/A
			N/A	DWS Length (in)	N/A
			N/A	DWS Full Width?	N/A
			N/A	DWS Offset (in)	N/A
			N/A	Gutter Ponding?	N/A
			N/A	Gutter Lip Ht (in)	0.5
			N/A	Painted X Walk1?	Yes
				X Walk 1 Direction	To E
			N/A	X Walk 1 Width (in)	110.0

X Walk 1 Slope (%)	1.6
				X Walk 1 X Slope (%)	3.3
			N/A	Ramp inside XWalk1?	Yes
				Road Slope (%)	1.3
				Road X Slope (%)	4.2
			N/A	Any Obstructions?	N/A
				Obstruction Type	
Total Cost: \$ 3200.00			N/A	Storm Grate/Utility Hazard?	N/A
				Storm Grate/Utility Type	
			N/A		N/A
			Yes	Surface Condition? (G/P)	Good
