Access Compliance Report Public Rights-of-Way (Curb Ramps)

Intersection ID: 20834 Main Street: COLONY CROSSING DR **Cross Street: COLONY RD** Location: SE **ADA ID: 6EBC2CEFED3C** Ramp Type: Directional1 Initial Pass/Fail: Fail **Overall Compliance: No Severity Score:** 12.5

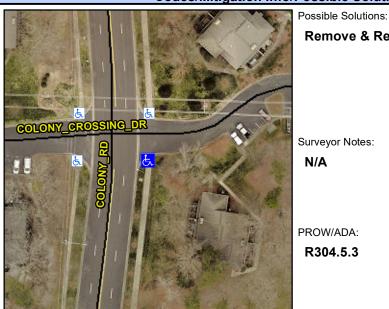
Field Measurements/Component Compliance							
Compliance Description		Data	Comp	liance Description	Data		
N/A	Ramp Length (in)	76.0	N/A	Grade Break?	N/A		
Yes	Ramp Width (in)	72.0	N/A	Grade Break Slope (%)	0.0		
Yes	Ramp Slope (%)	3.9	N/A	Grade Break XSlope (%)	0.0		
No	Ramp XSlope (%)	5.1					
N/A	Flare Type LT	N/A	N/A	Flare Type RT	N/A		
N/A	Flare Slope LT (%)	N/A	N/A	Flare Slope RT (%)	0.0		
N/A	Flare Traversable LT?	N/A	N/A	Flare Traversable RT?	N/A		
N/A	Landing Length (in)	0.0	N/A	DWS Provided?	N/A		
N/A	Landing Width (in)	0.0	N/A	DWS Contrast?	N/A		
N/A	Landing Slope (%)	0.0	N/A	DWS Length (in)	N/A		
N/A	Landing X Slope (%)	0.0	N/A	DWS Full Width?	N/A		
N/A	Landing Curb? (Y/N)	N/A	N/A	DWS Offset LT (in)	N/A		
N/A	Shared Landing?	N/A	N/A	DWS Offset RT (in)	N/A		
N/A	Gutter Ponding?	0.0	N/A	Gutter Slope (%)	N/A		
N/A	Gutter Lip Ht (in)	0.0	N/A	Gutter X Slope (%)	N/A		
N/A	Painted X Walk1?	No		Road Slope (%)	7.8

X Walk 1 Direction	To NW		Road X Slope (%)	6.5		
	X Walk 1 Width (in)	N/A		Clear Space?	N/A		
	X Walk 1 Slope (%)	7.8	N/A	Clear Space to XWalk (in)	N/A		
	X Walk 1 X Slope (%)	6.5	N/A	Storm Grate/Utility Hazard?	N/A		
N/A	Ramp inside XWalk1?	N/A		Storm Grate/Utility Type			
N/A	Any Obstructions?	N/A			N/A		
	Obstruction Type		Yes	Surface Condition? (G/P)	Good		
		N/A	N/A	Curb Slope (%)	9.0

Remove & Replace Entire Ramp.						
s	Surveyor Notes:						
	N/A						
4							
P	PROW/ADA:						
4	R304.5.3						
-
