Access Compliance Report Public Rights-of-Way (Curb Ramps)

Main Street: E MARTIN LUTHER KING JR @ Wss Street: S BREVARD ST Intersection ID: N/A Location: N

Overall Compliance: No Severity Score: ADA ID: 6EBFC723C51C Ramp Type: Perp Initial Pass/Fail: Fail 12.5

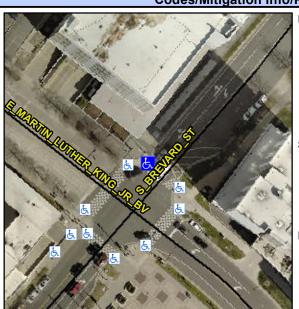
,	Possible Solutions:				
	Remove & Replace Entire Ramp.				
1					
Trans.					
1					
S. Carelli					
	Surveyor Notes:				
1	N/A				
-					
1					
1	PROW/ADA:				
0	R304.5.3				
Ž	11304.3.3
