Access Compliance Report Public Rights-of-Way (Curb Ramps)

Intersection ID: N/A Main Street: S BREVARD ST **Cross Street: E 3RD ST** Location: N ADA ID: 6EC42649D8C3 Ramp Type: Perp Initial Pass/Fail: Fail **Overall Compliance: No Severity Score:** 10

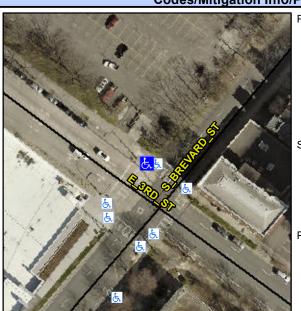
Field Measurements/Component Compliance						
Compliance Description		Data	Comp	liance	Description	Data
N/A	Ramp Length (in)	62.0	Yes	Ramp	Slope (%)	6.5
No	Ramp Width (in)	44.0	No	Ramp	XSlope (%)	2.5
N/A	Flare Type LT	N/A	N/A	Flare ⁻	Гуре RT	N/A
N/A	Flare Slope LT (%)	N/A	N/A	Flare	Slope RT (%)	N/A
N/A	Flare Traversable LT?	No	N/A	Flare ⁻	Traversable RT?	No
N/A	Landing Length (in)	N/A	N/A	DWS	Provided?	N/A
N/A	Landing Width (in)	N/A	N/A	DWS	Contrast?	N/A
N/A	Landing Slope (%)	N/A	N/A	DWS	Length (in)	N/A
N/A	Landing X Slope (%)	N/A	N/A	DWS	Full Width?	N/A
N/A	Landing Curb? (Y/N)	N/A	N/A	DWS	Offset (in)	N/A
N/A	Shared Landing?	N/A				
N/A	Gutter Ponding?	N/A	N/A	Gutter	Slope (%)	N/A
N/A	Gutter Lip Ht (in)	N/A	N/A	Gutter	X Slope (%)	N/A
N/A	Painted X Walk1?	Yes	N/A	Painte	d X Walk2?	N/A
	X Walk 1 Direction	To SW		X Wall	k 2 Direction	N/A
N/A	X Walk 1 Width (in)	103.0	N/A	X Wall	k 2 Width (in)	N/A
	X Walk 1 Slope (%)	2.1		X Wall	k 2 Slope (%)	N/A

X Walk 1 X Slope (%)	0.4		X Wall	k 2 X Slope (%)	N/A
N/A	Ramp inside XWalk1?	Yes	N/A	Ramp	inside XWalk2?	N/A
	Road Slope (%)	N/A	N/A	Clear	Space?	N/A
	Road X Slope (%)	N/A	N/A	Clear	Space to XWalk (in)	N/A
N/A	Any Obstructions?	N/A	N/A	Storm	Grate/Utility Hazard?	N/A
	Obstruction Type			Storm	Grate/Utility Type	
		N/A				N/A
			Yes	Surfac	e Condition? (G/P)	Good
	V

E 3RD ST Street 1 Name Stop Condition-Street 2 Signal Street 2 Name N/A Stop Condition-Street 1 N/A Possible Solutions: Remove & Replace Entire Ramp. Surveyor Notes: N/A PROW/ADA: Not Found, R304.5.1, R304.5.3
