## **Access Compliance Report Public Rights-of-Way** (Curb Ramps)

Intersection ID: 10020374 Main Street: BALLANTYNE\_CORPORATE\_PCross Street: N/A Location: S

**Overall Compliance: No ADA ID: 6EDF318A39D4** Ramp Type: Directional1 Initial Pass/Fail: Fail **Severity Score:** 1.25

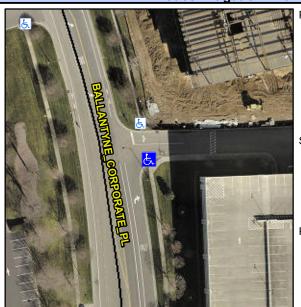
Compliance Description Data Compliance Description Data							
N/A	Ramp Length (in)	47.0	N/A	Grade Break?	N/A		
Yes	Ramp Width (in)	48.0	N/A	Grade Break Slope (%)	0.0		
Yes	Ramp Slope (%)	5.0	N/A	Grade Break XSlope (%)	0.0		
No	Ramp XSlope (%)	2.1		Grade Break Asiapa (76)	•.•		
N/A	Flare Type LT	N/A	N/A	Flare Type RT	N/A		
N/A	Flare Slope LT (%)	N/A	N/A	Flare Slope RT (%)	0.0		
N/A	Flare Traversable LT?	N/A	N/A	Flare Traversable RT?	N/A		
N/A	Landing Length (in)	0.0	N/A	DWS Provided?	N/A		
N/A	Landing Width (in)	0.0	N/A	DWS Contrast?	N/A		
N/A	Landing Slope (%)	0.0	N/A	DWS Length (in)	N/A		
N/A	Landing X Slope (%)	0.0	N/A	DWS Full Width?	N/A		
N/A	Landing Curb? (Y/N)	N/A	N/A	DWS Offset LT (in)	N/A		
N/A	Shared Landing?	N/A	N/A	DWS Offset RT (in)	N/A		
N/A	Gutter Ponding?	0.0	N/A	Gutter Slope (%)	N/A		
N/A	Gutter Lip Ht (in)	0.0	N/A	Gutter X Slope (%)	N/A		
N/A	Painted X Walk1?	No		Road Slope (%)	4.0		
	X Walk 1 Direction	To NW		Road X Slope (%)	3.6

X Walk 1 Width (in)	N/A		Clear Space?	N/A		
	X Walk 1 Slope (%)	4.0	N/A	Clear Space to XWalk (in)	N/A		
	X Walk 1 X Slope (%)	3.6	N/A	Storm Grate/Utility Hazard?	N/A		
N/A	Ramp inside XWalk1?	N/A		Storm Grate/Utility Type			
N/A	Any Obstructions?	N/A			N/A		
	Obstruction Type		Yes	Surface Condition? (G/P)	Good		
		N/A	N/A	Curb Slope (%)	5.0

Possible Solutions:	2
Remove & Replace Entire Ramp.	1
	١
	١
	N
	N
	N
Surveyor Notes:	N
N/A	1
	N
	1
	1
PROW/ADA:	1
R304.5.3	N
	1
	ı
	ı
