Access Compliance Report Public Rights-of-Way (Curb Ramps)

Intersection ID: 48606 Main Street: PIEDMONT ROW DR **Cross Street: CARNEGIE BV** Location: SE **Overall Compliance: No ADA ID: 6EDF63F7F502** Ramp Type: Perp Initial Pass/Fail: Fail **Severity Score:** 12.5

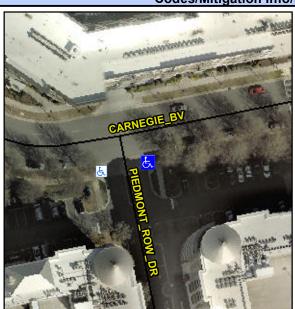
Comp	liance Description	Data	Comp	oliance	Description	Data
N/A	Ramp Length (in)	89.0	No	Ramp	Slope (%)	10.9
Yes	Ramp Width (in)	48.0	Yes	Ramp	XSlope (%)	0.8
N/A	Flare Type LT	N/A	N/A	Flare T	ype RT	N/A
N/A	Flare Slope LT (%)	N/A	N/A	Flare S	Slope RT (%)	N/A
N/A	Flare Traversable LT?	N/A	N/A	Flare T	raversable RT?	N/A
N/A	Landing Length (in)	N/A	N/A	DWS F	Provided?	N/A
N/A	Landing Width (in)	N/A	N/A	DWS (Contrast?	N/A
N/A	Landing Slope (%)	N/A	N/A	DWS L	ength (in)	N/A
N/A	Landing X Slope (%)	N/A	N/A	DWS F	Full Width?	N/A
N/A	Landing Curb? (Y/N)	N/A	N/A	DWS (Offset (in)	N/A
N/A	Shared Landing?	N/A				
N/A	Gutter Ponding?	N/A	N/A	Gutter	Slope (%)	N/A
N/A	Gutter Lip Ht (in)	N/A	N/A	Gutter	X Slope (%)	N/A
N/A	Painted X Walk1?	No	N/A	Painte	d X Walk2?	N/A
	X Walk 1 Direction	To W		X Walk	2 Direction	N/A
N/A	X Walk 1 Width (in)	N/A	N/A	X Walk	c 2 Width (in)	N/A
	X Walk 1 Slope (%)	1.4		X Walk	(2 Slope (%)	N/A
	X Walk 1 X Slope (%)	1.6		X Walk	(2 X Slope (%)	N/A

N/A	Ramp inside XWalk1?	N/A	N/A	Ramp	inside XWalk2?	N/A
	Road Slope (%)	N/A	N/A	Clear S	Space?	N/A
	Road X Slope (%)	N/A	N/A	Clear S	Space to XWalk (in)	N/A
N/A	Any Obstructions?	N/A	N/A	Storm	Grate/Utility Hazard?	N/A
	Obstruction Type		l	Storm	Grate/Utility Type	
		N/A				N/A
			Yes	Surfac	e Condition? (G/P)	Good
16	. 411		-

Possible Solutions:	9
Remove & Replace Entire Ramp.	N
	Y
	N
	N
	N
	N
Surveyor Notes:	N
N/A	N
	N
	N
	N
PROW/ADA:	N
R304.2.2	N
	N
	N

N/A		N/A
		N/A
		N/A
		N/A
PROW/ADA:		N/A
R304.2.2		N/A
		N/A
		N/A
		N/A
Total Cost:	\$ 1850.00	N/A
