Access Compliance Report

Public Rights-of-Way

(Curb Ramps)

Intersection ID: 49384	Main Street: SOUTH_DEVON_ST	Cross Street: SHORTHORN_ST	Location: S
ADA ID: 6EE14E892619	Ramp Type: PerpDiag	Initial Pass/Fail: Fail	Overall Compliance: No
			Severity Score: 21.25

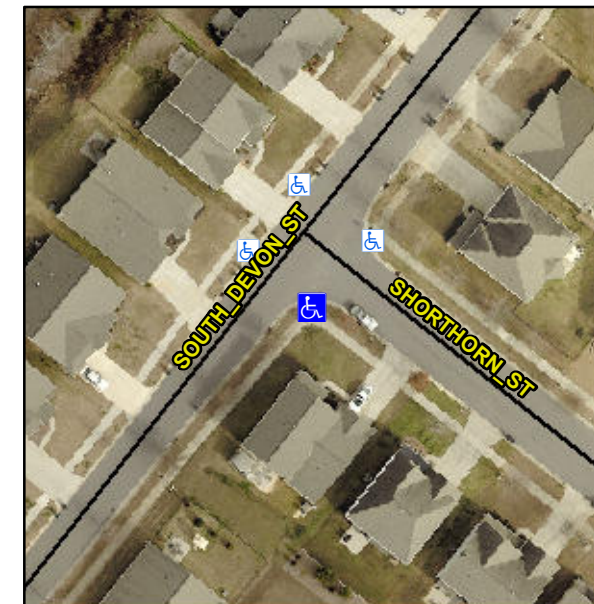
Not Found, R304.5.1, R304.2.2

Compliance	Description	Data	Compliance	Description	Data
N/A	Ramp Length (in)	82.0	No	Ramp Slope (%)	8.9
No	Ramp Width (in)	47.5	Yes	Ramp XSlope (%)	0.1
N/A	Flare Type LT	N/A	N/A	Flare Type RT	N/A
N/A	Flare Slope LT (%)	N/A	N/A	Flare Slope RT (%)	N/A
N/A	Flare Traversable LT?	N/A	N/A	Flare Traversable RT?	N/A
N/A	Landing Length (in)	N/A	N/A	DWS Provided?	N/A
N/A	Landing Width (in)	N/A	N/A	DWS Contrast?	N/A
N/A	Landing Slope (%)	N/A	N/A	DWS Length (in)	N/A
N/A	Landing X Slope (%)	N/A	N/A	DWS Full Width?	N/A
N/A	Landing Curb? (Y/N)	N/A	N/A	DWS Offset (in)	N/A
N/A	Shared Landing?	N/A			
N/A	Gutter Ponding?	N/A	N/A	Gutter Slope (%)	N/A
N/A	Gutter Lip Ht (in)	N/A	N/A	Gutter X Slope (%)	N/A
N/A	Painted X Walk1?	No	N/A	Painted X Walk2?	No
	X Walk 1 Direction	To NE		X Walk 2 Direction	To NW
N/A	X Walk 1 Width (in)	N/A	N/A	X Walk 2 Width (in)	N/A
	X Walk 1 Slope (%)	0.9		X Walk 2 Slope (%)	2.4
	X Walk 1 X Slope (%)	2.4		X Walk 2 X Slope (%)	1.7

N/A	Ramp inside XWalk1?	N/A	N/A	Ramp inside XWalk2?	N/A
	Road Slope (%)	0.3	N/A	Clear Space?	N/A
	Road X Slope (%)	0.9	N/A	Clear Space to XWalk (in)	N/A
N/A	Any Obstructions?	N/A	N/A	Storm Grate/Utility Hazard?	N/A
	Obstruction Type			Storm Grate/Utility Type	
		N/A			N/A
			Yes	Surface Condition? (G/P)	Good

Remove & Replace Curb Ramp With Two New Directional Ramps or Equivalent.
