# Access Compliance Report

## Public Rights-of-Way

### (Curb Ramps)

Intersection ID: 11780	Main Street: E_20TH_ST	Cross Street: PEGRAM_ST	Location: W
ADA ID: 6EEB1E694031	Ramp Type: BlendTrans2	Initial Pass/Fail: Fail	Overall Compliance: No
Severity Score: 25			
Codes/Mitigation Info/Possible Solution		Field Measurements/Component Compliance

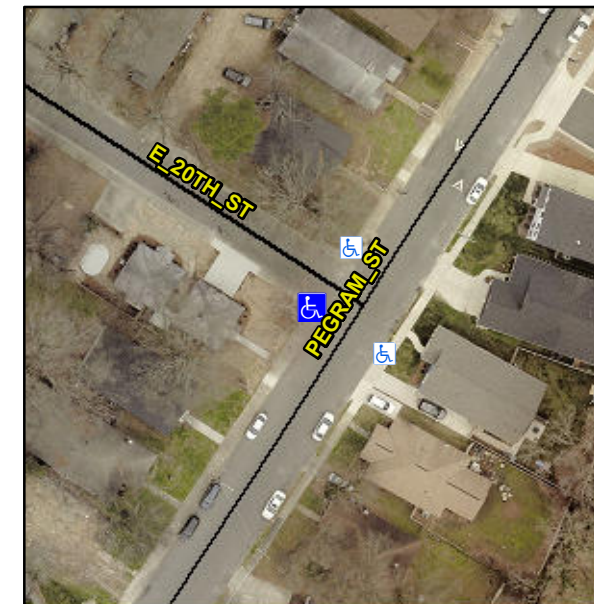
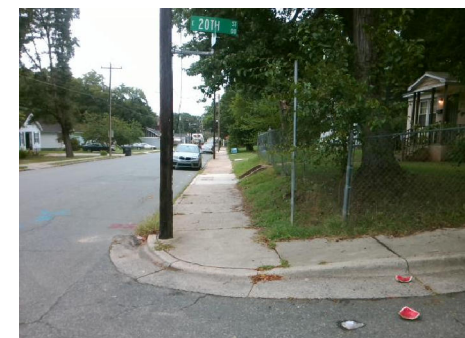
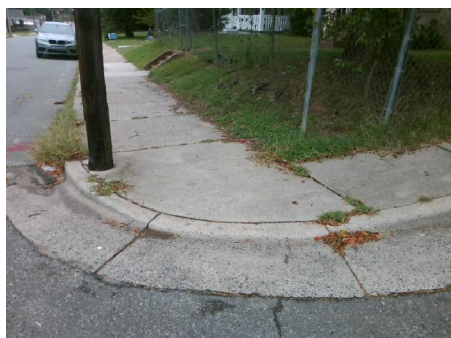
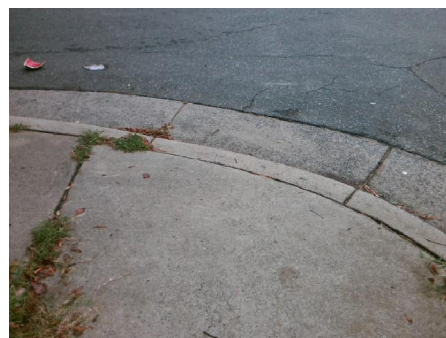
Compliance	Description	Data	Compliance	Description	Data
N/A	Ramp Length (in)	47.5	Yes	BlendTrans Slope (%)	2.9
Yes	Ramp Width (in)	49.5	No	BlendTrans XSlope (%)	11.3
N/A	Flare Type LT	N/A	N/A	Flare Type RT	N/A
N/A	Flare Slope LT (%)	N/A	N/A	Flare Slope RT (%)	N/A
N/A	Flare Traversable LT?	N/A	N/A	Flare Traversable RT?	N/A
N/A	Landing Length (in)	N/A	N/A	DWS Provided?	N/A
N/A	Landing Width (in)	N/A	N/A	DWS Contrast?	N/A
N/A	Landing Slope (%)	N/A	N/A	DWS Length (in)	N/A
N/A	Landing X Slope (%)	N/A	N/A	DWS Full Width?	N/A
N/A	Landing Curb? (Y/N)	N/A	N/A	DWS Offset (in)	N/A
N/A	Shared Landing?	N/A			
N/A	Gutter Ponding?	N/A	N/A	Gutter Slope (%)	N/A
N/A	Gutter Lip Ht (in)	N/A	N/A	Gutter X Slope (%)	N/A
N/A	Painted X Walk1?	No	N/A	Painted X Walk2?	No
	X Walk 1 Direction	To SE		X Walk 2 Direction	To NE
	X Walk 1 Width (in)	N/A		X Walk 2 Width (in)	N/A
	X Walk 1 Slope (%)	2.8		X Walk 2 Slope (%)	5.0
	X Walk 1 X Slope (%)	3.1		X Walk 2 X Slope (%)	0.0

N/A	Ramp inside XWalk1?	N/A	N/A	Ramp inside XWalk2?	N/A
	Road Slope (%)	2.5		Clear Space?	N/A
	Road X Slope (%)	3.9	N/A	Clear Space to XWalk (in)	N/A
N/A	Any Obstructions?	N/A	N/A	Storm Grate/Utility Hazard?	N/A
	Obstruction Type			Storm Grate/Utility Type	
		N/A			N/A
			Yes	Surface Condition? (G/P)	Good
			N/A	Curb Slope (%)	N/A

**Remove & Replace Curb Ramp With Two New Directional Ramps or Equivalent.**

**R304.5.3**
