Access Compliance Report

Public Rights-of-Way

(Curb Ramps)

Intersection ID: 21151	Main Street: CARMEL_RD	Cross Street: MULLENS_FORD_RD	Location: NW
ADA ID: 6EEC0EEBFDF6	Ramp Type: PerpDiag	Initial Pass/Fail: Fail	Overall Compliance: No
Severity Score: 12.5			
Codes/Mitigation Info/Possible Solution		Field Measurements/Component Compliance

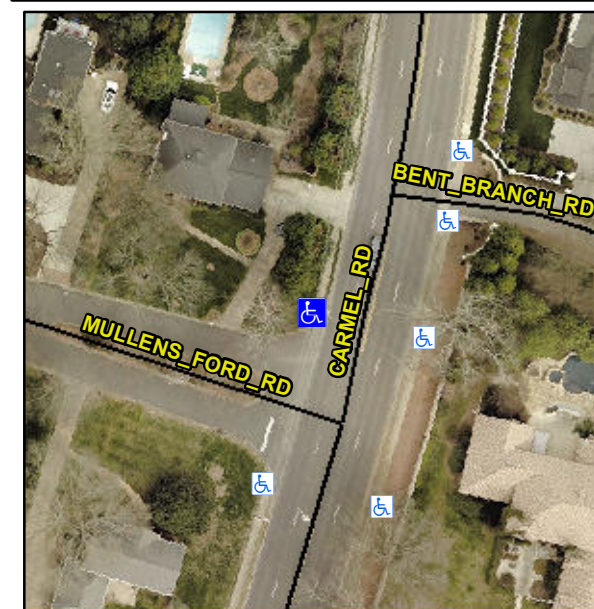
Not Found, R304.2.2

Compliance	Description	Data	Compliance	Description	Data
N/A	Ramp Length (in)	41.0	No	Ramp Slope (%)	10.2
Yes	Ramp Width (in)	48.0	Yes	Ramp XSlope (%)	2.0
N/A	Flare Type LT	N/A	N/A	Flare Type RT	N/A
N/A	Flare Slope LT (%)	N/A	N/A	Flare Slope RT (%)	N/A
N/A	Flare Traversable LT?	N/A	N/A	Flare Traversable RT?	N/A
N/A	Landing Length (in)	N/A	N/A	DWS Provided?	N/A
N/A	Landing Width (in)	N/A	N/A	DWS Contrast?	N/A
N/A	Landing Slope (%)	N/A	N/A	DWS Length (in)	N/A
N/A	Landing X Slope (%)	N/A	N/A	DWS Full Width?	N/A
N/A	Landing Curb? (Y/N)	N/A	N/A	DWS Offset (in)	N/A
N/A	Shared Landing?	N/A			
N/A	Gutter Ponding?	N/A	N/A	Gutter Slope (%)	N/A
N/A	Gutter Lip Ht (in)	N/A	N/A	Gutter X Slope (%)	N/A
N/A	Painted X Walk1?	No	N/A	Painted X Walk2?	No
	X Walk 1 Direction	To SW		X Walk 2 Direction	To SE
N/A	X Walk 1 Width (in)	N/A	N/A	X Walk 2 Width (in)	N/A
	X Walk 1 Slope (%)	0.9		X Walk 2 Slope (%)	2.2
	X Walk 1 X Slope (%)	5.9		X Walk 2 X Slope (%)	1.9

N/A	Ramp inside XWalk1?	N/A	N/A	Ramp inside XWalk2?	N/A
	Road Slope (%)	2.1	N/A	Clear Space?	N/A
	Road X Slope (%)	8.3	N/A	Clear Space to XWalk (in)	N/A
N/A	Any Obstructions?	N/A	N/A	Storm Grate/Utility Hazard?	N/A
	Obstruction Type			Storm Grate/Utility Type	
		N/A			N/A
		Yes		Surface Condition? (G/P)	Good

Remove & Replace Curb Ramp With Two New Directional Ramps or Equivalent.
