Access Compliance Report

Public Rights-of-Way

(Curb Ramps)

Intersection ID: 13754	Main Street: S_MCDOWELL_ST	Cross Street: BAXTER_ST	Location:	N
ADA ID: 6EF58E6CF99A	Ramp Type: PerpDiag	Initial Pass/Fail: Fail	Overall Compliance: No	Severity Score: 37.5

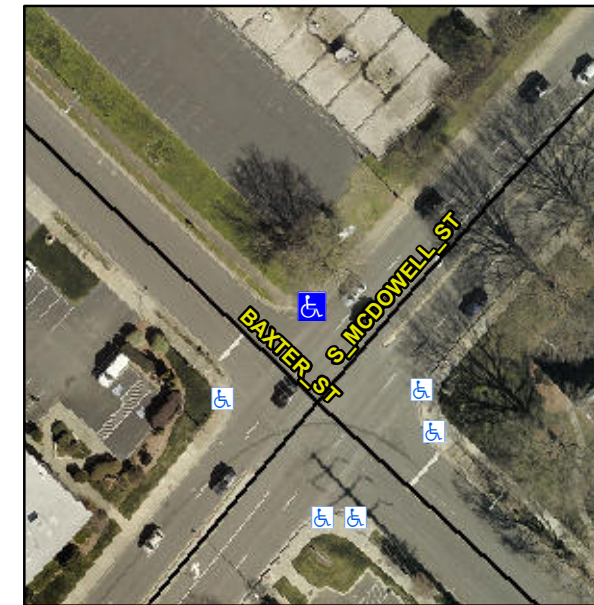
Compliance	Description	Data	Compliance	Description	Data
N/A	Ramp Length (in)	72.0	No	Ramp Slope (%)	12.3
Yes	Ramp Width (in)	72.0	No	Ramp XSlope (%)	6.4
N/A	Flare Type LT	N/A	N/A	Flare Type RT	N/A
N/A	Flare Slope LT (%)	N/A	N/A	Flare Slope RT (%)	N/A
N/A	Flare Traversable LT?	N/A	N/A	Flare Traversable RT?	N/A
N/A	Landing Length (in)	N/A	N/A	DWS Provided?	N/A
N/A	Landing Width (in)	N/A	N/A	DWS Contrast?	N/A
N/A	Landing Slope (%)	N/A	N/A	DWS Length (in)	N/A
N/A	Landing X Slope (%)	N/A	N/A	DWS Full Width?	N/A
N/A	Landing Curb? (Y/N)	N/A	N/A	DWS Offset (in)	N/A
N/A	Shared Landing?	N/A			
N/A	Gutter Ponding?	N/A	N/A	Gutter Slope (%)	N/A
N/A	Gutter Lip Ht (in)	N/A	N/A	Gutter X Slope (%)	N/A
N/A	Painted X Walk1?	No	N/A	Painted X Walk2?	No
	X Walk 1 Direction	To SW		X Walk 2 Direction	To SE
N/A	X Walk 1 Width (in)	N/A	N/A	X Walk 2 Width (in)	N/A
	X Walk 1 Slope (%)	0.1		X Walk 2 Slope (%)	4.3
	X Walk 1 X Slope (%)	4.9		X Walk 2 X Slope (%)	2.4

N/A	Ramp inside XWalk1?	N/A	N/A	Ramp inside XWalk2?	N/A
	Road Slope (%)	4.3	N/A	Clear Space?	N/A
	Road X Slope (%)	3.3	N/A	Clear Space to XWalk (in)	N/A
N/A	Any Obstructions?	N/A	N/A	Storm Grate/Utility Hazard?	N/A
	Obstruction Type			Storm Grate/Utility Type	
		N/A			N/A
			Yes	Surface Condition? (G/P)	Good

Remove & Replace Curb Ramp With Two New Directional Ramps or Equivalent.

R304.2.2, R304.5.3
