Intersection ID: 12151	Main Street: W_MOREHEAD_ST	Cross Street: MILLERTON_AV	Location:	S
ADA ID: 6F07FE239294	Ramp Type: Perp	Initial Pass/Fail: Pass	Overall Compliance: No	Severity Score: 5

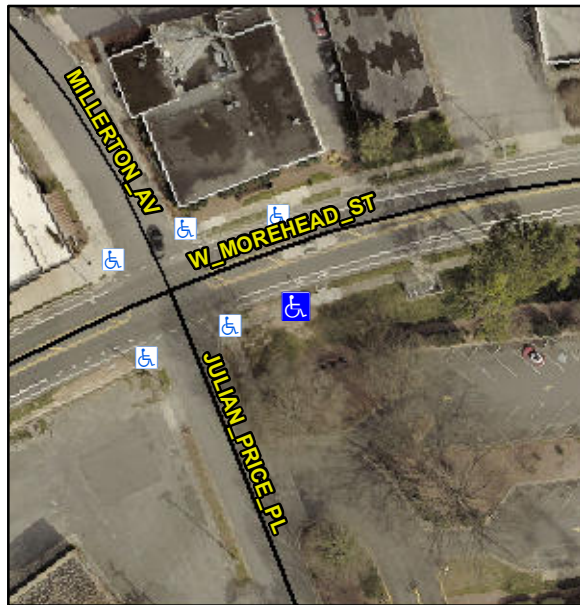
Street 1 Name	W MOREHEAD ST
Stop Condition-Street 2	None
Street 2 Name	N/A
Stop Condition-Street 1	N/A

**Not Found, R305.2, R304.5.4,
R304.5.3**

Compliance	Description	Data	Compliance	Description	Data
N/A	Ramp Length (in)	47.0	Yes	Ramp Slope (%)	6.7
Yes	Ramp Width (in)	58.0	Yes	Ramp XSlope (%)	1.4
Yes	Flare Type L	Curbed_NoWalkSurface	Yes	Flare Type RT	N/A
Yes	Flare Slope LT (%)	N/A	N/A	Flare Slope RT (%)	N/A
N/A	Flare Traversable LT?	No	N/A	Flare Traversable RT?	No
Yes	Landing Length (in)	66.0	Yes	DWS Provided?	Yes
Yes	Landing Width (in)	58.0	Yes	DWS Contrast?	Yes
Yes	Landing Slope (%)	1.8	Yes	DWS Length (in)	24.0
Yes	Landing X Slope (%)	1.4	Yes	DWS Full Width?	Yes
N/A	Landing Curb? (Y/N)	Yes	No	DWS Offset (in)	5.0
N/A	Shared Landing?	Yes			
Yes	Gutter Ponding?	No	No	Gutter Slope (%)	5.4
Yes	Gutter Lip Ht (in)	0.0	No	Gutter X Slope (%)	2.4
N/A	Painted X Walk1?	No	N/A	Painted X Walk2?	N/A
	X Walk 1 Direction	To N		X Walk 2 Direction	N/A
N/A	X Walk 1 Width (in)	N/A	N/A	X Walk 2 Width (in)	N/A
	X Walk 1 Slope (%)	4.7		X Walk 2 Slope (%)	N/A
	X Walk 1 X Slope (%)	1.2		X Walk 2 X Slope (%)	N/A

N/A	Ramp inside XWalk1?	N/A	N/A	Ramp inside XWalk2?	N/A
	Road Slope (%)	N/A	N/A	Clear Space?	Yes
	Road X Slope (%)	N/A	N/A	Clear Space to XWalk (in)	N/A
Yes	Any Obstructions?	No	Yes	Storm Grate/Utility Hazard?	No
	Obstruction Type			Storm Grate/Utility Type	
		N/A			N/A
			Yes	Surface Condition? (G/P)	Good

**Remove & Replace Entire Ramp.
Remove & Replace Gutter.**

Total Cost: \$ 2600.00
