## Access Compliance Report Public Rights-of-Way (Curb Ramps)

Intersection ID: 30036 Main Street: KEMPSFORD\_DR Cross Street: ROCHDALE\_LN Location: NW

ADA ID: 6F0DBA60D9C9 Ramp Type: PerpDiag Initial Pass/Fail: Fail Overall Compliance: No Severity Score: 0

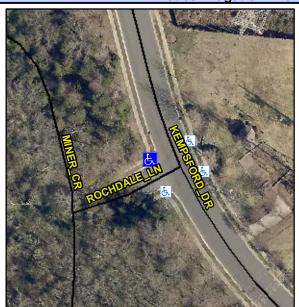
| Field Measurements/Component Compliance | | | | | |
|---|---|---|---|---|---|
| N/A | Ramp Length (in) | 48.0 | Yes | Ramp Slope (%) | 6.4 |
| Yes | Ramp Width (in) | 48.0 | Yes | Ramp XSlope (%) | 1.9 |

Remove & Replace Curb Ramp With Two New Directional Ramps or Equivalent.
