# Access Compliance Report

## Public Rights-of-Way

| Intersection ID: 14226 | Main Street: AROSA_AV | Cross Street: E_MOREHEAD_ST | Location: W |
| ADA ID: 6F155F89B7DA | Ramp Type: PerpDiag | Initial Pass/Fail: Pass | Overall Compliance: No |

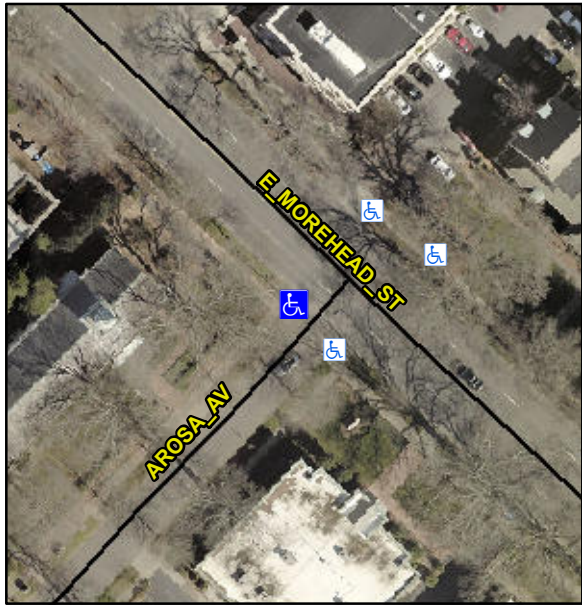
| Codes/Mitigation Info/Possible Solution | | | Field Measurements/Component Compliance | | | | | |
|---|---|---|---|---|---|---|---|---|
| | | | Yes | Landing X Slope (%) | 0.9 | No | DWS Full Width? | No |
| <p>Surveyor Notes:</p> <p>N/A</p> <p>PROW/ADA:</p> <p>R305.1.4, R305.2, R302.7, R304.5.4</p> | | | N/A | Landing Curb? (Y/N) | No | No | DWS Offset (in) | 10.0 |
| | | | No | Gutter Ponding? | Yes | No | Gutter Slope (%) | 7.1 |

| Codes/Mitigation Info/Possible Solution | | | Field Measurements/Component Compliance | | | | | |
|---|---|---|---|---|---|---|---|---|
| | Remove & Replace Detectable Warning System. Remove & Replace Gutter. | | N/A | Ramp Length (in) | 108.0 | Yes | Ramp Slope (%) | 7.0 |
