Access Compliance Report Public Rights-of-Way (Curb Ramps)

Intersection ID: 2412 Main Street: HIDDEN_MEADOW_LN Cross Street: LAUREL_RUN_DR Location: S

ADA ID: 6F1D47603CDC Ramp Type: PerpDiag Initial Pass/Fail: Fail Overall Compliance: No Severity Score: 13.75

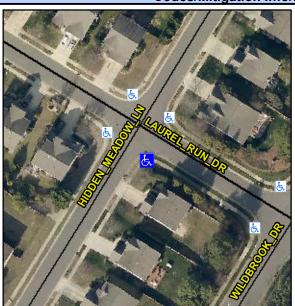
Compliance Description Data Compliance Description Data No N/A Ramp Length (in) 47.0 Ramp Slope (%) 10.4 No Yes Ramp Width (in) 48.0 Ramp XSlope (%) 2.7 N/A N/A Flare Type LT N/A Flare Type RT N/A N/A N/A Flare Slope RT (%) Flare Slope LT (%) N/A N/A N/A Flare Traversable LT? N/A N/A Flare Traversable RT? N/A N/A N/A N/A DWS Provided? N/A Landing Length (in) N/A Landing Width (in) N/A N/A **DWS Contrast?** N/A N/A N/A Landing Slope (%) N/A DWS Length (in) N/A N/A Landing X Slope (%) N/A N/A DWS Full Width? N/A N/A Landing Curb? (Y/N) N/A N/A DWS Offset (in) N/A N/A N/A Shared Landing? N/A Gutter Ponding? N/A N/A Gutter Slope (%) N/A N/A Gutter Lip Ht (in) N/A N/A Gutter X Slope (%) N/A N/A Painted X Walk1? No N/A Painted X Walk2? No X Walk 1 Direction To NE X Walk 2 Direction To NW N/A N/A X Walk 1 Width (in) X Walk 2 Width (in) N/A X Walk 1 Slope (%) 2.6 X Walk 2 Slope (%) 3.5 X Walk 1 X Slope (%) 2.1 X Walk 2 X Slope (%) 0.3 N/A N/A N/A Ramp inside XWalk2? N/A Ramp inside XWalk1? Road Slope (%) 1.7 N/A Clear Space? N/A N/A Road X Slope (%) 3.6 Clear Space to XWalk (in) N/A

Remove & Replace Curb Ramp With Two New Directional Ramps or Equivalent.
