## **Access Compliance Report Public Rights-of-Way** (Curb Ramps)

Intersection ID: 13736 Main Street: CAMDEN RD Cross Street: E PARK AV Location: Ε Initial Pass/Fail: Fail **Overall Compliance: No Severity Score:**

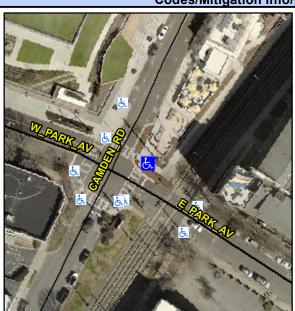
Compliance Description Data Compliance Description Yes Ramp Slope (%) N/A Ramp Length (in) 53.0 Yes Ramp XSlope (%) No Ramp Width (in) 44.0 N/A N/A Flare Type LT N/A Flare Type RT N/A N/A N/A Flare Slope RT (%) Flare Slope LT (%) N/A Flare Traversable LT? N/A N/A Flare Traversable RT? N/A N/A N/A **DWS Provided?** Landing Length (in) N/A Landing Width (in) N/A N/A **DWS Contrast?** N/A N/A N/A Landing Slope (%) DWS Length (in) N/A Landing X Slope (%) N/A N/A DWS Full Width? N/A Landing Curb? (Y/N) N/A N/A DWS Offset (in) N/A N/A Shared Landing? N/A **Gutter Ponding?** N/A N/A Gutter Slope (%) N/A Gutter Lip Ht (in) N/A N/A Gutter X Slope (%) N/A Painted X Walk1? Yes N/A Painted X Walk2? X Walk 1 Direction To NW X Walk 2 Direction N/A 98.0 N/A X Walk 1 Width (in) X Walk 2 Width (in) X Walk 1 Slope (%) 3.7 X Walk 2 Slope (%) X Walk 1 X Slope (%) 0.9 X Walk 2 X Slope (%) N/A N/A Ramp inside XWalk2? Ramp inside XWalk1? Yes Road Slope (%) 0.8 N/A Clear Space? N/A Road X Slope (%) 3.1 Clear Space to XWalk (in) N/A N/A N/A Any Obstructions? Storm Grate/Utility Hazard? **Obstruction Type** Storm Grate/Utility Type N/A

**CAMDEN RD** Street 1 Name Stop Condition-Street 2 Signal **E PARK AV** Street 2 Name Stop Condition-Street 1 Signal Possible Solutions: Remove & Replace Curb Ramp With Two New Directional Ramps or Equivalent. Surveyor Notes: N/A PROW/ADA: R304.5.1
