Access Compliance Report Public Rights-of-Way (Curb Ramps)

Intersection ID: N/A	Main Street: ENDHAVEN_LN		Cross Street: MEGWOOD_DR				Location:	SW	
ADA ID: 6F22F2FB0D0A	Ramp Ty	/pe: PerpDiag	Initial Pass/	nitial Pass/Fail: Pass Overall Compliance: No			o Severity Score:	10.25	
Codes/Mitigation Info/Possible Solution				Field Measurements/Component Compliance					
The second second		Possible Solutions:	Con	Compliance Description Dat				Data	
		Remove & Replace Curb Ramp W Two New Directional Ramps or Equivalent.	/ith N/A	Ramp Length (in)	47.0	Yes	Ramp Slope (%)	6.0	
			Yes	Ramp Width (in)	48.0	No	Ramp XSlope (%)	5.0	
			N/A	Flare Type LT	Sloped	N/A	Flare Type RT	N/A	
The second se			N/A	Flare Slope LT (%)	3.2		Flare Slope RT (%)	4.0	
			N/A	Flare Traversable LT?	Yes	N/A	Flare Traversable RT?	Yes	
ENDHAVEN_LIN			No	Landing Length (in)	N/A	Yes	DWS Provided?	Yes	
C C C C C C C C C C C C C C C C C C C		Surveyor Notes:	No	Landing Width (in)	N/A	Yes	DWS Contrast?	Yes

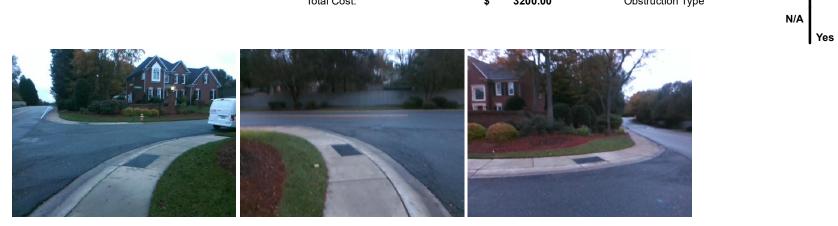
N/A	No	Landing Slope (%)	N/A	Yes	DWS Length (in)	24.0	
			No	Landing X Slope (%)	N/A	Yes	DWS Full Width?	Yes	
			N/A	Landing Curb? (Y/N)	No	No	DWS Offset (in)	3.0	
			N/A	Shared Landing?	N/A				
		PROW/ADA:	Yes	Gutter Ponding?	No	Yes	Gutter Slope (%)	2.6	
		Not Found, R304.5.3, R304.2.1,	Yes	Gutter Lip Ht (in)	0.0	Yes	Gutter X Slope (%)	1.9	
		R304.2.2-Perp, R304.3.2-Para,	N/A	Painted X Walk1?	No	N/A	Painted X Walk2?	No	
		R305.2		X Walk 1 Direction	To E		X Walk 2 Direction	To N	
			N/A	X Walk 1 Width (in)	N/A	N/A	X Walk 2 Width (in)	N/A	
Street 1 Name	MEGWOOD DR	-		X Walk 1 Slope (%)	0.6		X Walk 2 Slope (%)	1.7	
Stop Condition-Street 2	StopSign			X Walk 1 X Slope (%)	2.1		X Walk 2 X Slope (%)	1.9	
Street 2 Name	ENDHAVEN LN		N/A	Ramp inside XWalk1?	N/A	N/A	Ramp inside XWalk2?	N/A	
Stop Condition-Street 1	None			Road Slope (%)	2.2	N/A	Clear Space?	Yes	
				Road X Slope (%)	0.0	N/A	Clear Space to XWalk (in)	N/A

Yes	Any Obstructions?	No	Yes	Storm Grate/Utility Hazard?	No	
		Total Cost: \$ 32	200.00	Obstruction Type			Storm Grate/Utility Type		
					N/A			N/A	
1

s Surface Condition? (G/P)

Good
