Access Compliance Report

Public Rights-of-Way

(Curb Ramps)

Intersection ID: 28622	Main Street: PEDLAR_MILLS_RD	Cross Street: STRINGFELLOW_LN	Location: NW
ADA ID: 6F2301FC129D	Ramp Type: PerpDiag	Initial Pass/Fail: Fail	Overall Compliance: No
Severity Score: 10			
Codes/Mitigation Info/Possible Solution		Field Measurements/Component Compliance

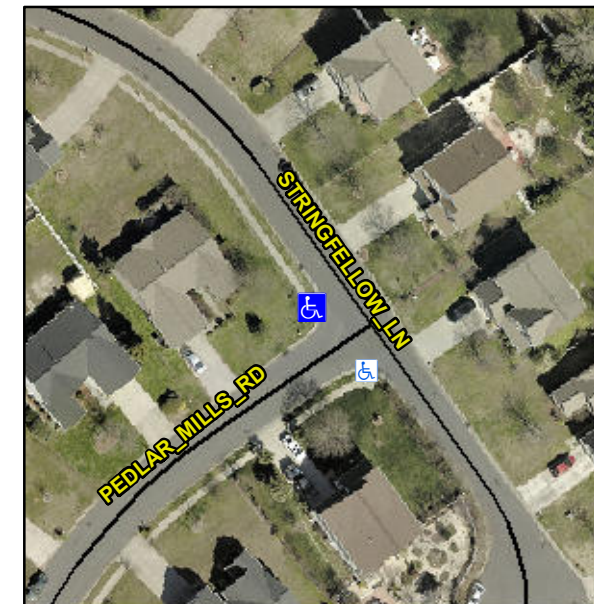
Compliance	Description	Data	Compliance	Description	Data
N/A	Ramp Length (in)	51.0	Yes	Ramp Slope (%)	7.7
No	Ramp Width (in)	42.3	No	Ramp XSlope (%)	3.5
N/A	Flare Type LT	N/A	N/A	Flare Type RT	N/A
N/A	Flare Slope LT (%)	N/A	N/A	Flare Slope RT (%)	N/A
N/A	Flare Traversable LT?	N/A	N/A	Flare Traversable RT?	N/A
N/A	Landing Length (in)	N/A	N/A	DWS Provided?	N/A
N/A	Landing Width (in)	N/A	N/A	DWS Contrast?	N/A
N/A	Landing Slope (%)	N/A	N/A	DWS Length (in)	N/A
N/A	Landing X Slope (%)	N/A	N/A	DWS Full Width?	N/A
N/A	Landing Curb? (Y/N)	N/A	N/A	DWS Offset (in)	N/A
N/A	Shared Landing?	N/A			
N/A	Gutter Ponding?	N/A	N/A	Gutter Slope (%)	N/A
N/A	Gutter Lip Ht (in)	N/A	N/A	Gutter X Slope (%)	N/A
N/A	Painted X Walk1?	No	N/A	Painted X Walk2?	No
	X Walk 1 Direction	To SE		X Walk 2 Direction	To NE
N/A	X Walk 1 Width (in)	N/A	N/A	X Walk 2 Width (in)	N/A
	X Walk 1 Slope (%)	1.1		X Walk 2 Slope (%)	6.1
	X Walk 1 X Slope (%)	0.5		X Walk 2 X Slope (%)	1.1

N/A	Ramp inside XWalk1?	N/A	N/A	Ramp inside XWalk2?	N/A
	Road Slope (%)	0.8	N/A	Clear Space?	N/A
	Road X Slope (%)	0.4	N/A	Clear Space to XWalk (in)	N/A
N/A	Any Obstructions?	N/A	N/A	Storm Grate/Utility Hazard?	N/A
	Obstruction Type			Storm Grate/Utility Type	
		N/A			N/A
			Yes	Surface Condition? (G/P)	Good

Remove & Replace Curb Ramp With Two New Directional Ramps or Equivalent.

R304.5.1, R304.5.3
