# Access Compliance Report

## Public Rights-of-Way

### (Curb Ramps)

Intersection ID: 10737	Main Street: S_BRUNS_AV	Cross Street: SUMTER_AV	Location: NW
ADA ID: 6F2DFD1D3A53	Ramp Type: PerpDiag	Initial Pass/Fail: Fail	Overall Compliance: No
			Severity Score: 46.25

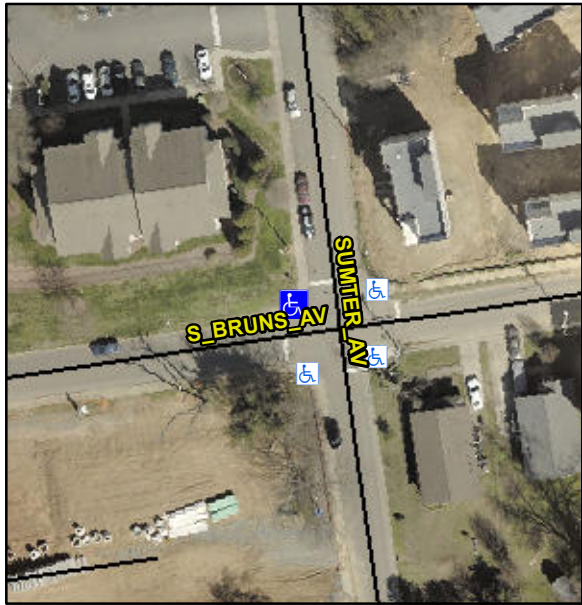
Possible Solutions:	Compliance	Description	Data	Compliance	Description	Data
	Remove & Replace Curb Ramp With Two New Directional Ramps or Equivalent.	N/A	Ramp Length (in)	59.0	No	Ramp Slope (%)	10.3
		No	Ramp Width (in)	40.0	No	Ramp XSlope (%)	9.0
		N/A	Flare Type LT	N/A	N/A	Flare Type RT	N/A
	N/A	Flare Slope LT (%)	N/A	N/A	Flare Slope RT (%)	N/A	
	N/A	Flare Traversable LT?	N/A	N/A	Flare Traversable RT?	N/A	
	N/A	Landing Length (in)	N/A	N/A	DWS Provided?	N/A	
	N/A	Landing Width (in)	N/A	N/A	DWS Contrast?	N/A	
	N/A	Landing Slope (%)	N/A	N/A	DWS Length (in)	N/A	
	N/A	Landing X Slope (%)	N/A	N/A	DWS Full Width?	N/A	
N/A	Landing Curb? (Y/N)	N/A	N/A	DWS Offset (in)	N/A		
Surveyor Notes:	N/A	N/A	Shared Landing?	N/A			
		N/A	Gutter Ponding?	N/A	N/A	Gutter Slope (%)	N/A
		N/A	Gutter Lip Ht (in)	0.5	N/A	Gutter X Slope (%)	N/A

PROW/ADA:	N/A	Painted X Walk1?	No	N/A	Painted X Walk2?	No
			X Walk 1 Direction	To S		X Walk 2 Direction	To E
		N/A	X Walk 1 Width (in)	N/A	N/A	X Walk 2 Width (in)	N/A
			X Walk 1 Slope (%)	1.6		X Walk 2 Slope (%)	4.1
			X Walk 1 X Slope (%)	3.3		X Walk 2 X Slope (%)	6.2
		N/A	Ramp inside XWalk1?	N/A	N/A	Ramp inside XWalk2?	N/A
			Road Slope (%)	5.0	N/A	Clear Space?	N/A
	Road X Slope (%)	2.0	N/A	Clear Space to XWalk (in)	N/A		
Total Cost:	\$ 3200.00	N/A	Any Obstructions?	N/A	N/A	Storm Grate/Utility Hazard?	N/A
			Obstruction Type			Storm Grate/Utility Type	
				N/A		N/A	
				Yes	Surface Condition? (G/P)	Good
