# Access Compliance Report

## Public Rights-of-Way

### (Curb Ramps)

| Intersection ID: 30441 | Main Street: ELM_BEND_DR | Cross Street: CADENCE_CT | Location: | N |

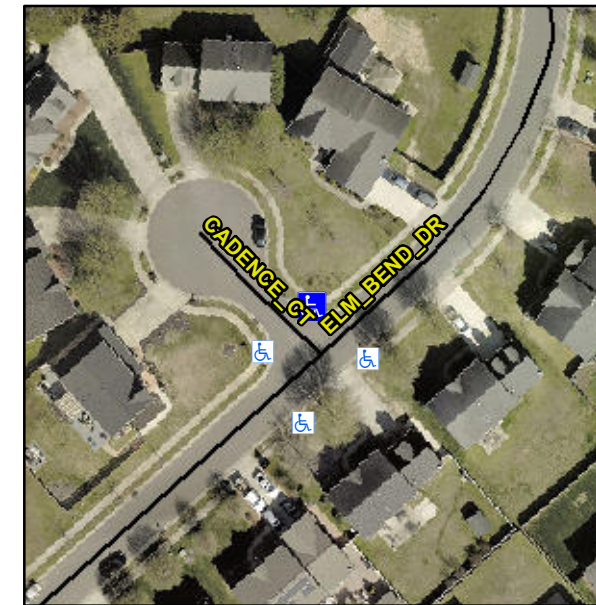
| ADA ID: 6F3353495D1D | Ramp Type: PerpDiag | Initial Pass/Fail: Fail | Overall Compliance: No | Severity Score: 10 |

**R304.5.1, R304.5.3**

| Compliance | Description | Data | Compliance | Description | Data |
|---|---|---|---|---|---|
| N/A | Ramp Length (in) | 46.0 | Yes | Ramp Slope (%) | 6.2 |
| No | Ramp Width (in) | 47.0 | No | Ramp XSlope (%) | 2.7 |

**Remove & Replace Curb Ramp With Two New Directional Ramps or Equivalent.**
