Access Compliance Report

Public Rights-of-Way

(Curb Ramps)

Intersection ID: 17865	Main Street: OVERHILL_RD	Cross Street: S_WENDOVER_RD	Location: S
ADA ID: 6F4399D4B20A	Ramp Type: PerpDiag	Initial Pass/Fail: Fail	Overall Compliance: No
		Severity Score: 25

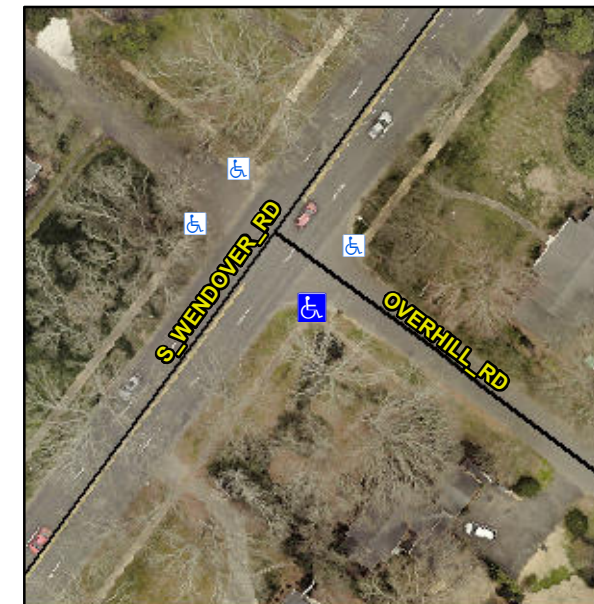
Not Found, R304.2.2, R304.5.3

Compliance	Description	Data	Compliance	Description	Data
N/A	Ramp Length (in)	63.0	No	Ramp Slope (%)	10.3
Yes	Ramp Width (in)	48.0	No	Ramp XSlope (%)	5.2
N/A	Flare Type LT	N/A	N/A	Flare Type RT	N/A
N/A	Flare Slope LT (%)	N/A	N/A	Flare Slope RT (%)	N/A
N/A	Flare Traversable LT?	N/A	N/A	Flare Traversable RT?	N/A
N/A	Landing Length (in)	N/A	N/A	DWS Provided?	N/A
N/A	Landing Width (in)	N/A	N/A	DWS Contrast?	N/A
N/A	Landing Slope (%)	N/A	N/A	DWS Length (in)	N/A
N/A	Landing X Slope (%)	N/A	N/A	DWS Full Width?	N/A
N/A	Landing Curb? (Y/N)	N/A	N/A	DWS Offset (in)	N/A
N/A	Shared Landing?	N/A			
N/A	Gutter Ponding?	N/A	N/A	Gutter Slope (%)	N/A
N/A	Gutter Lip Ht (in)	N/A	N/A	Gutter X Slope (%)	N/A
N/A	Painted X Walk1?	No	N/A	Painted X Walk2?	No
	X Walk 1 Direction	To NE		X Walk 2 Direction	To NW
N/A	X Walk 1 Width (in)	N/A	N/A	X Walk 2 Width (in)	N/A
	X Walk 1 Slope (%)	5.3		X Walk 2 Slope (%)	0.9
	X Walk 1 X Slope (%)	4.7		X Walk 2 X Slope (%)	5.9

N/A	Ramp inside XWalk1?	N/A	N/A	Ramp inside XWalk2?	N/A
	Road Slope (%)	5.4	N/A	Clear Space?	N/A
	Road X Slope (%)	4.5	N/A	Clear Space to XWalk (in)	N/A
N/A	Any Obstructions?	N/A	N/A	Storm Grate/Utility Hazard?	N/A
	Obstruction Type			Storm Grate/Utility Type	
		N/A			N/A
			Yes	Surface Condition? (G/P)	Good

Remove & Replace Curb Ramp With Two New Directional Ramps or Equivalent.
