Intersection ID: 14442	Main Street: N_SHARON_AMITY_RD	Cross Street: CENTRAL_AV	Location:	NW
ADA ID: 6F4ABAA671D9	Ramp Type: Para	Initial Pass/Fail: Fail	Overall Compliance: No	Severity Score: 13.75

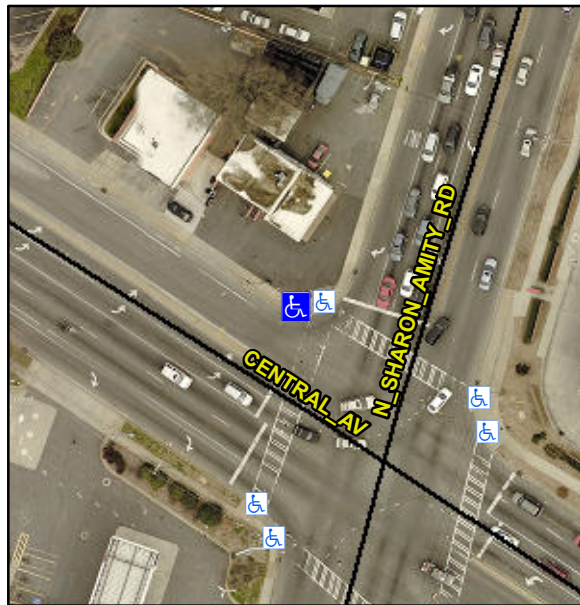
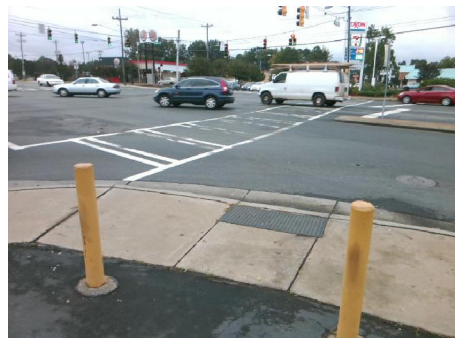
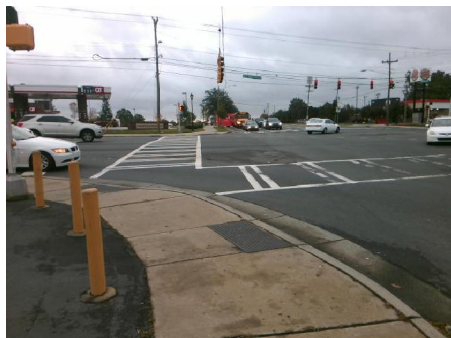
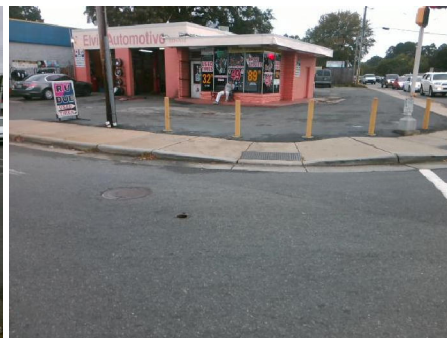
LT RP < 5%

R304.3.2, R304.5.3

Compliance	Description	Data	Compliance	Description	Data
N/A	Ramp Length LT (in)	56.5	N/A	Ramp Length RT (in)	51.5
Yes	Ramp Width LT (in)	72.0	Yes	Ramp Width RT (in)	72.0
Yes	Ramp Slope LT (%)	1.8	No	Ramp Slope RT (%)	10.7
Yes	Ramp XSlope LT (%)	1.9	No	Ramp XSlope RT (%)	4.0
N/A	Landing Length (in)	N/A	N/A	DWS Provided?	N/A
N/A	Landing Width (in)	N/A	N/A	DWS Contrast?	N/A
N/A	Landing Slope (%)	N/A	N/A	DWS Length (in)	N/A
N/A	Landing X Slope (%)	N/A	N/A	DWS Full Width?	N/A
N/A	Landing Curb? (Y/N)	N/A	N/A	DWS Offset (in)	N/A
N/A	Shared Landing?	N/A			
N/A	Gutter Ponding?	N/A	N/A	Gutter Slope (%)	N/A
N/A	Gutter Lip Ht (in)	N/A	N/A	Gutter X Slope (%)	N/A
N/A	Painted X Walk1?	No	N/A	Painted X Walk2?	N/A
	X Walk 1 Direction	To SW		X Walk 2 Direction	N/A
N/A	X Walk 1 Width (in)	N/A	N/A	X Walk 2 Width (in)	N/A
	X Walk 1 Slope (%)	3.7		X Walk 2 Slope (%)	N/A
	X Walk 1 X Slope (%)	1.3		X Walk 2 X Slope (%)	N/A
N/A	Ramp inside XWalk1?	N/A	N/A	Ramp inside XWalk2?	N/A

Remove & Replace Entire Ramp.
