Access Compliance Report Public Rights-of-Way (Curb Ramps)

Intersection ID: 13936Main Street:S_KINGS_DRCross Street:CHARLOTTETOWNE_AVLocation:NWADA ID: 6F5635E99998Ramp Type:PerpInitial Pass/Fail:FailOverall Compliance:NoSeverity Score:13.75

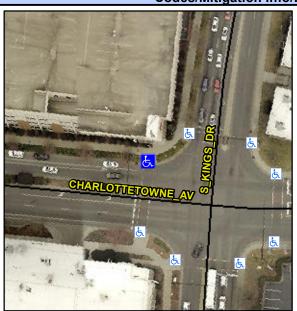
/Possible Solution	Fleid Measurements/Component Compliance				
Possible Solutions:	Compliance Description		Data	Comp	liance Description
Remove & Replace Entire Ramp.	N/A	Ramp Length (in)	48.0	No	Ramp Slope (%)
· ·	Yes	Ramp Width (in)	48.0	No	Ramp XSlope (%)
	N/A	Flare Type LT	N/A	N/A	Flare Type RT
	N/A	Flare Slope LT (%)	N/A	N/A	Flare Slope RT (%)
	N/A	Flare Traversable LT?	N/A	N/A	Flare Traversable RT?
	N/A	Landing Length (in)	N/A	N/A	DWS Provided?
Surveyor Notes:	N/A	Landing Width (in)	N/A	N/A	DWS Contrast?
N/A	N/A	Landing Slope (%)	N/A	N/A	DWS Length (in)
	N/A	Landing X Slope (%)	N/A	N/A	DWS Full Width?
	N/A	Landing Curb? (Y/N)	N/A	N/A	DWS Offset (in)
	N/A	Shared Landing?	N/A		
PROW/ADA:	N/A	Gutter Ponding?	N/A	N/A	Gutter Slope (%)
R304.2.2, R304.5.3	N/A	Gutter Lip Ht (in)	N/A	N/A	Gutter X Slope (%)
	N/A	Painted X Walk1?	Yes	N/A	Painted X Walk2?
		X Walk 1 Direction	To S		X Walk 2 Direction
	N/A	X Walk 1 Width (in)	121.0	N/A	X Walk 2 Width (in)

X Walk 1 Slope (%)	2.2		X Walk 2 Slope (%)
		X Walk 1 X Slope (%)	3.9		X Walk 2 X Slope (%)
	N/A	Ramp inside XWalk1?	Yes	N/A	Ramp inside XWalk2?
		Road Slope (%)	N/A	N/A	Clear Space?
		Road X Slope (%)	N/A	N/A	Clear Space to XWalk (in)
	N/A	Any Obstructions?	N/A	N/A	Storm Grate/Utility Hazard?
