## **Access Compliance Report Public Rights-of-Way** (Curb Ramps)

Intersection ID: 29824 Main Street: MARVIN\_RD **Cross Street: WILKLEE DR** Location: ADA ID: 6F582A986321 Ramp Type: PerpDiag Initial Pass/Fail: Fail **Overall Compliance: No Severity Score:** 37.5

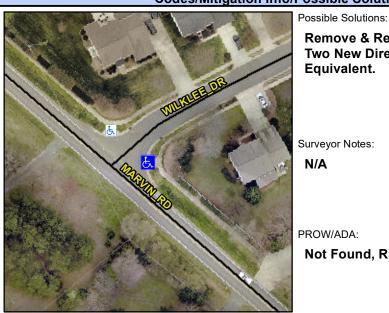
Not Found, R304.2.2, R304.5.3

Field Measurements/Component Compnance					
Compliance Description I		Data	Compliance Description		Data
N/A	Ramp Length (in)	111.0	No	Ramp Slope (%)	13.8
Yes	Ramp Width (in)	58.0	No	Ramp XSlope (%)	5.8
N/A	Flare Type LT	N/A	N/A	Flare Type RT	N/A
N/A	Flare Slope LT (%)	N/A	N/A	Flare Slope RT (%)	N/A
N/A	Flare Traversable LT?	N/A	N/A	Flare Traversable RT?	N/A
N/A	Landing Length (in)	N/A	N/A	DWS Provided?	N/A
N/A	Landing Width (in)	N/A	N/A	DWS Contrast?	N/A
N/A	Landing Slope (%)	N/A	N/A	DWS Length (in)	N/A
N/A	Landing X Slope (%)	N/A	N/A	DWS Full Width?	N/A
N/A	Landing Curb? (Y/N)	N/A	N/A	DWS Offset (in)	N/A
N/A	Shared Landing?	N/A			
N/A	Gutter Ponding?	N/A	N/A	Gutter Slope (%)	N/A
N/A	Gutter Lip Ht (in)	N/A	N/A	Gutter X Slope (%)	N/A
N/A	Painted X Walk1?	No	N/A	Painted X Walk2?	No
	X Walk 1 Direction	To NW		X Walk 2 Direction	To SW
N/A	X Walk 1 Width (in)	N/A	N/A	X Walk 2 Width (in)	N/A
	X Walk 1 Slope (%)	1.1		X Walk 2 Slope (%)	0.4

X Walk 1 X Slope (%)	0.4		X Walk 2 X Slope (%)	0.4
N/A	Ramp inside XWalk1?	N/A	N/A	Ramp inside XWalk2?	N/A
	Road Slope (%)	0.2	N/A	Clear Space?	N/A
	Road X Slope (%)	0.8	N/A	Clear Space to XWalk (in)	N/A
N/A	Any Obstructions?	N/A	N/A	Storm Grate/Utility Hazard?	N/A
	Obstruction Type			Storm Grate/Utility Type	
		N/A			N/A
			Yes	Surface Condition? (G/P)	Good

Remove & Replace Curb Ramp With Two New Directional Ramps or Equivalent.
