# Access Compliance Report

## Public Rights-of-Way

### (Curb Ramps)

| Intersection ID: 48945 | Main Street: DAVID_JENNINGS_AV | Cross Street: CALDWELL_RIDGE_PY | Location: N |

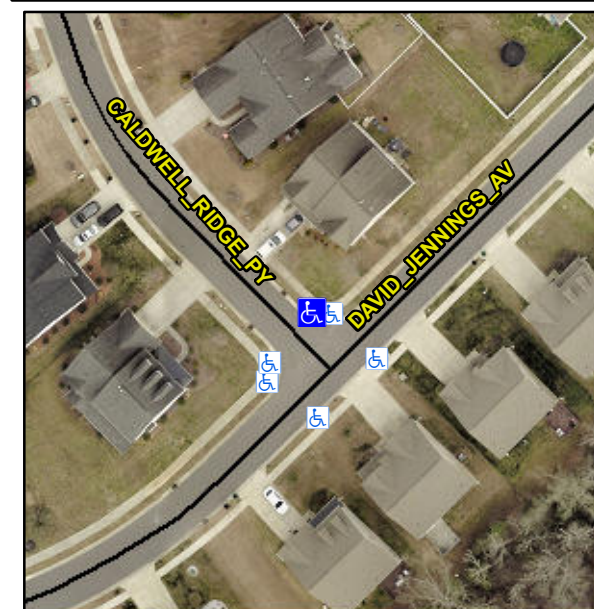
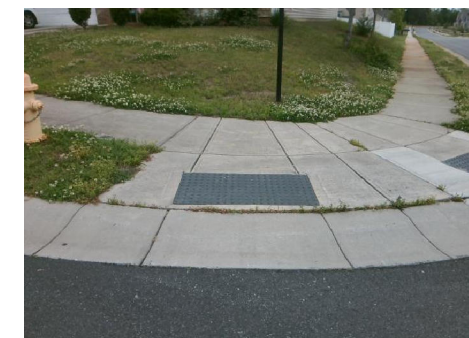
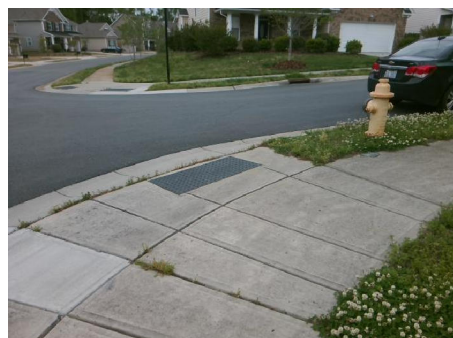
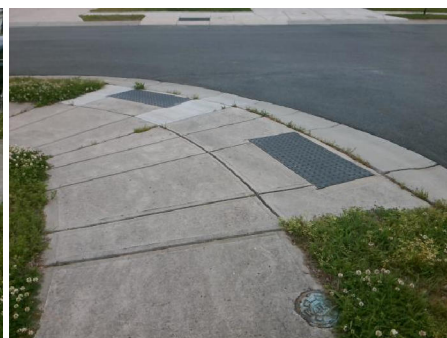
| ADA ID: 6F70ACAF7809 | Ramp Type: Combination1 | Initial Pass/Fail: Fail | Overall Compliance: No |

**Not Found, R304.5.1, R304.5.3, R304.3.2**

| Compliance | Description | Data | Compliance | Description | Data |
|---|---|---|---|---|---|
| No | Ramp Slope LT (%) | 8.9 | Yes | Ramp Slope RT (%) | 6.0 |
| Yes | Ramp XSlope LT (%) | 1.1 | No | Ramp XSlope RT (%) | 3.1 |
| No | Ramp Width (in) | 37.5 | No | Ramp XSlope (%) | 5.2 |

**Remove & Replace Entire Ramp.**

Total Cost: \$ 1800.00
