# Access Compliance Report

## Public Rights-of-Way

### (Curb Ramps)

Intersection ID: 5708	Main Street: PLEASANT GROVE RD	Cross Street: OAKDALE GREEN DR	Location: W
ADA ID: 6F768B7651B5	Ramp Type: Perp	Initial Pass/Fail: Fail	Overall Compliance: No
Severity Score: 22.5			
Codes/Mitigation Info/Possible Solution		Field Measurements/Component Compliance

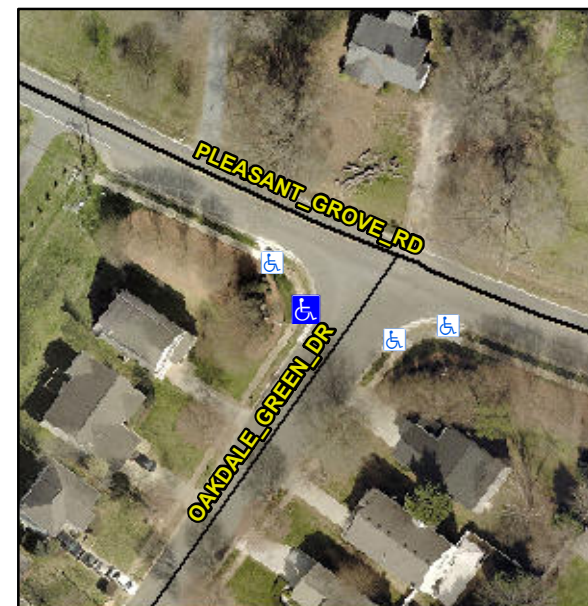
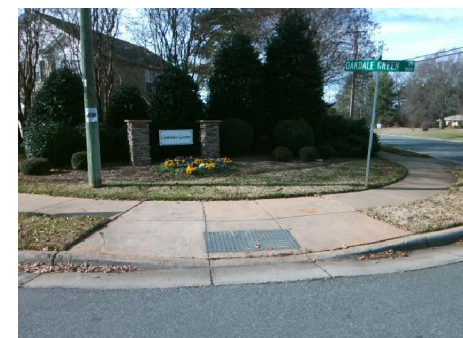
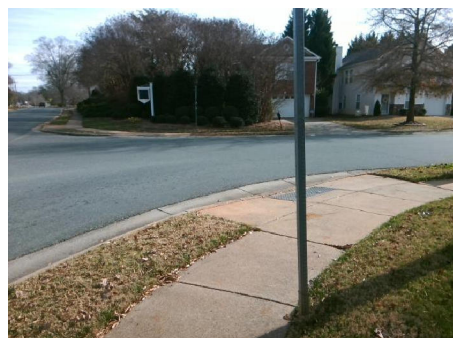
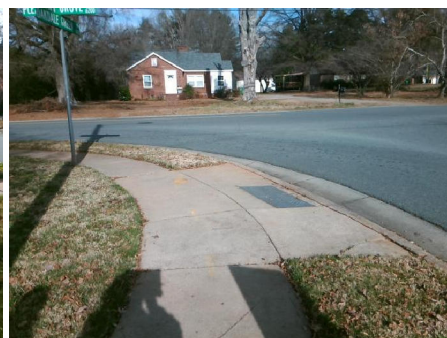
**R304.5.1, R304.2.2, R304.5.3**

Compliance	Description	Data	Compliance	Description	Data
N/A	Ramp Length (in)	45.5	No	Ramp Slope (%)	11.6
No	Ramp Width (in)	42.0	No	Ramp XSlope (%)	3.0
N/A	Flare Type LT	N/A	N/A	Flare Type RT	N/A
N/A	Flare Slope LT (%)	N/A	N/A	Flare Slope RT (%)	N/A
N/A	Flare Traversable LT?	N/A	N/A	Flare Traversable RT?	N/A
N/A	Landing Length (in)	N/A	N/A	DWS Provided?	N/A
N/A	Landing Width (in)	N/A	N/A	DWS Contrast?	N/A
N/A	Landing Slope (%)	N/A	N/A	DWS Length (in)	N/A
N/A	Landing X Slope (%)	N/A	N/A	DWS Full Width?	N/A
N/A	Landing Curb? (Y/N)	N/A	N/A	DWS Offset (in)	N/A
N/A	Shared Landing?	N/A			
N/A	Gutter Ponding?	N/A	N/A	Gutter Slope (%)	N/A
N/A	Gutter Lip Ht (in)	N/A	N/A	Gutter X Slope (%)	N/A
N/A	Painted X Walk1?	No	N/A	Painted X Walk2?	N/A
	X Walk 1 Direction	To S		X Walk 2 Direction	N/A
N/A	X Walk 1 Width (in)	N/A	N/A	X Walk 2 Width (in)	N/A
	X Walk 1 Slope (%)	1.6		X Walk 2 Slope (%)	N/A
	X Walk 1 X Slope (%)	0.9		X Walk 2 X Slope (%)	N/A

N/A	Ramp inside XWalk1?	N/A	N/A	Ramp inside XWalk2?	N/A
	Road Slope (%)	N/A	N/A	Clear Space?	N/A
	Road X Slope (%)	N/A	N/A	Clear Space to XWalk (in)	N/A
N/A	Any Obstructions?	N/A	N/A	Storm Grate/Utility Hazard?	N/A
	Obstruction Type			Storm Grate/Utility Type	
		N/A			N/A
			Yes	Surface Condition? (G/P)	Good

**Remove & Replace Entire Ramp.**

Total Cost: \$ **1850.00**
